## Expertise

Protocol number: 46299474  
Order No. / Reference: 26520999  
Inspection date: 2 Jul 2026

Manufacturer: Opel

Model: Mokka-e Elegance

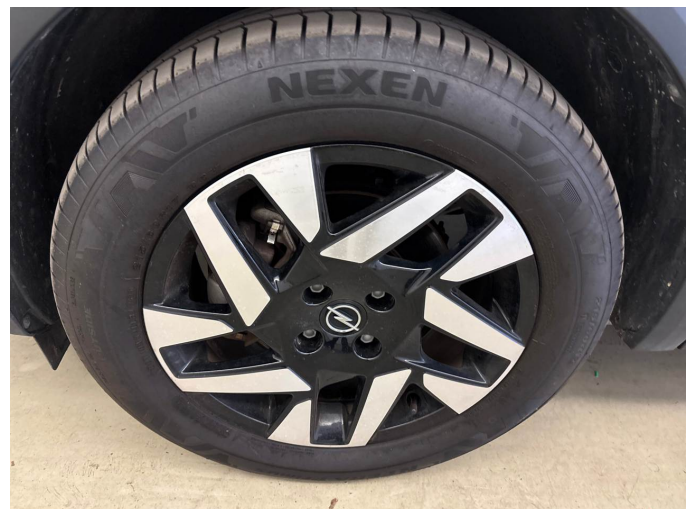
Figure 12: Mounted tyres

#	Tyre size	Type of tyre	Manufacturer	Tread depth
1)	215/60 R17 96H	Summer tyres on Light alloy	Nexen	4mm / 4mm
2)	215/60 R17 96H	Summer tyres on Light alloy	Nexen	5mm / 5mm
