Expertise

Protocol number: 45519350
Order No. / Reference: 26260022
Inspection date: 8 May 2026

Manufacturer: Opel

Model: Astra Sports Tourer 1.5 D Automatik Elegance

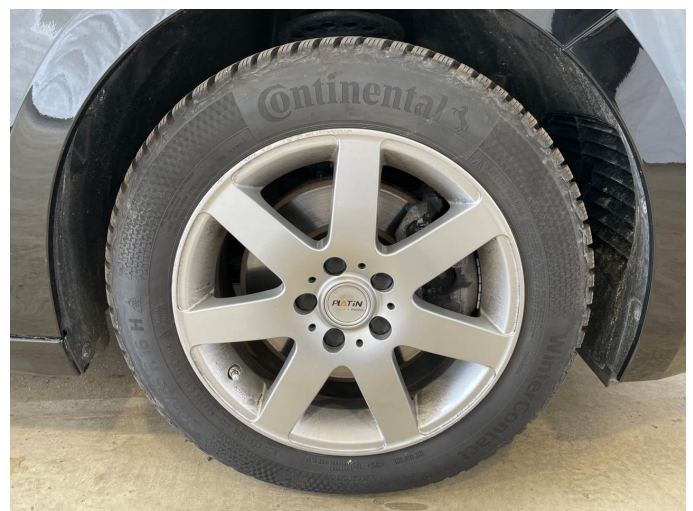
Figure 12: Mounted tyres

#	Tyre size	Type of tyre	Manufacturer	Tread depth
1)	205/55 R16 91H	Winter tyres on Light alloy	Continental	7mm / 7mm
2)	205/55 R16 91H	Winter tyres on Light alloy	Continental	7mm / 7mm

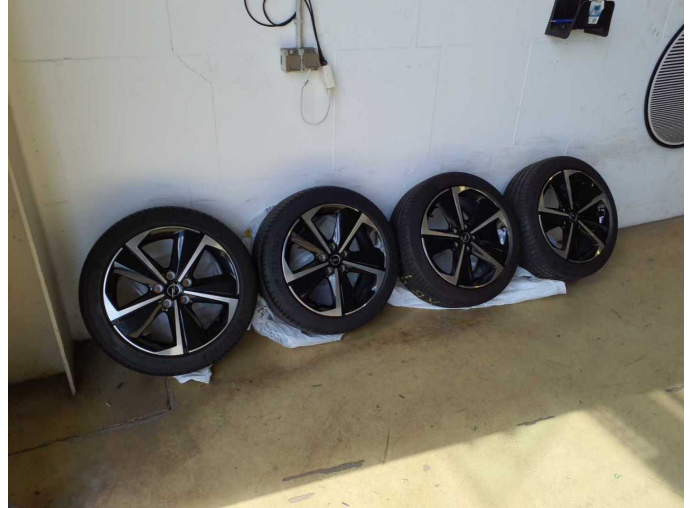
Figure 14: Additional tyres

Der montierte Winterradsatz ist kein Bestandteil der Ausstattung.
