Expertise

Protocol number: 46346868
Order No. / Reference: 26595600
Inspection date: 3 Jul 2026

Manufacturer: Peugeot

Model: 208 Elektromotor 136 Allure

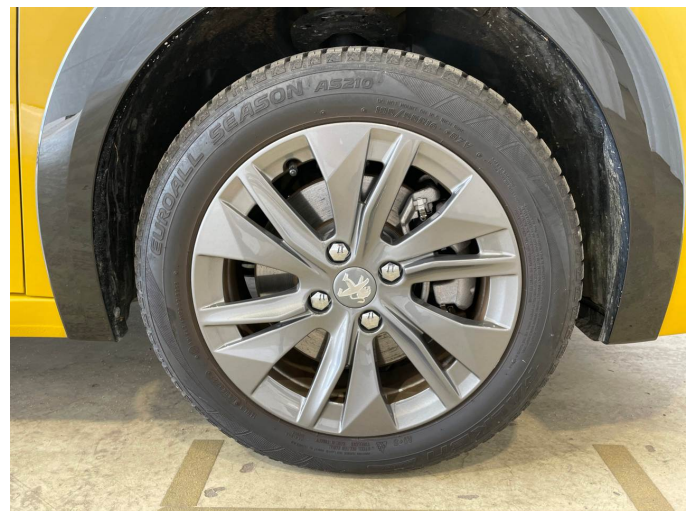
Figure 12: Mounted tyres

Mounted tyres				
#	Tyre size	Type of tyre	Manufacturer	Tread depth
1)	195/55 R16 87V	All-season tyres on Light alloy	Falken	6mm / 6mm
2)	195/55 R16 87V	All-season tyres on Light alloy	Falken	7mm / 7mm
Replacement				
Typ	Tyre size	Type of tyre	Manufacturer	Tread depth
	Tirefit	Expiration date 08/2028
