Expertise

Protocol number: 46374799
Order No. / Reference: 26472594
Inspection date: 6 Jul 2026

Model: Boxer HDi 335 L2H2 S&S Pro

VIN: VF3YCBNFB12N60167

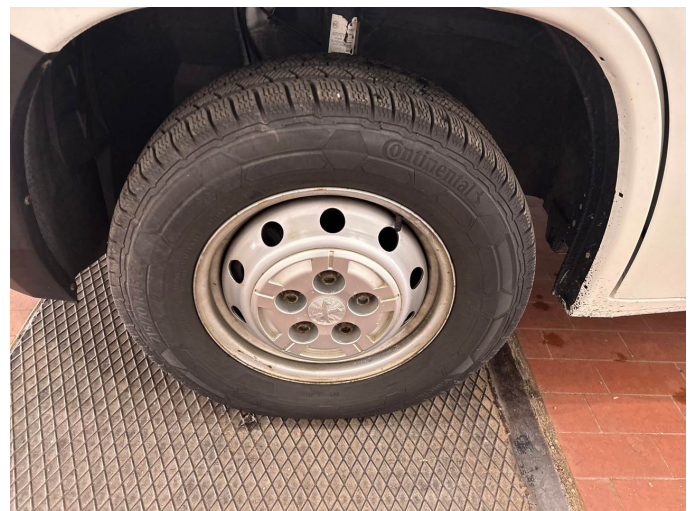
#	Tyre size	Type of tyre	Manufacturer	Tread depth
1)	215/70 R15 109R	Winter tyres on Steel rim with wheel cover	Continental	6mm / 6mm
2)	215/70 R15 109R	Winter tyres on Steel rim with wheel cover	Continental	6mm / 6mm

Figure 12: Mounted tyres
