Expertise

Protocol number: 46163330
Order No. / Reference: 26002512
Inspection date: 22 Jun 2026

Model: Vito 110 CDI Lang VA Kasten

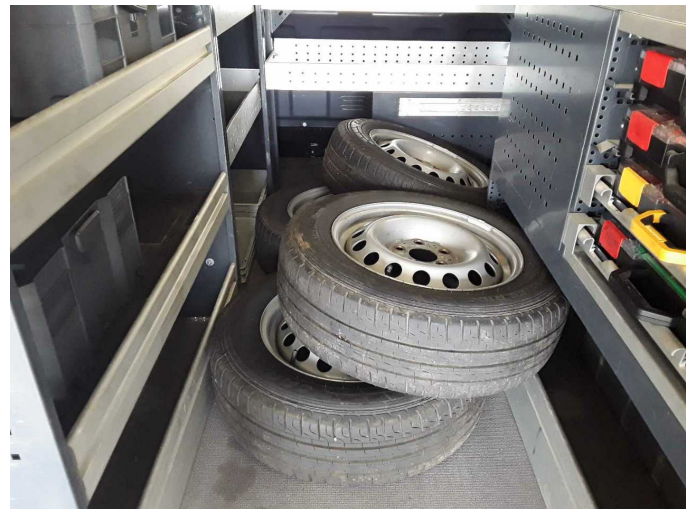
Figure 16: Additional tyres

- Der montierte Winterradsatz ist kein Bestandteil des Auslieferungsumfangs.
- Für den montierten Radsatz wurde kein Nachweis erbracht.
- Winterradsatz ist kein Bestandteil des Auslieferungsumfangs.
