Expertise

Protocol number: 45701431
Order No. / Reference: 26373117
Inspection date: 29 May 2026

Model: Kodiaq 2.0 TDI DSG Tour

VIN: TMBJJ7NSXP8038822

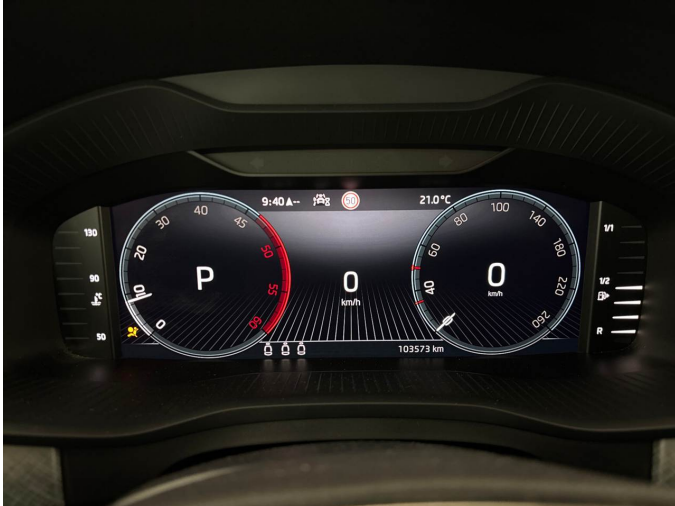
Figure 7: Instrument cluster

No.	Component group	Description
1	Roof	Roof rail - right side - dent(s) - Smart repair
2	Instrument panel	Indicator light (Airbag) - on - Perform
3	Bonnet	Bonnet (Verätzungen) - Paint defect - Paint
4	Vehicle glazing	Windscreen - Stone chips - Replace
