Expertise

Protocol number: 45905125
Order No. / Reference: 26487907
Inspection date: 11 Jun 2026

Manufacturer: Volvo

Model: XC60 T8 AWD Recharge Geartronic R-Design

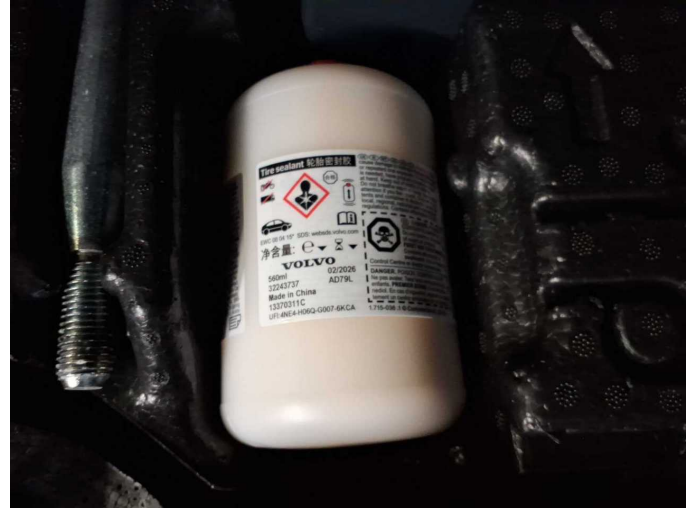
Damage 1: Equipment: Tirefit filler - Expired - Replace
