Expertise

Protocol number: 45232666  
Order No. / Reference: 26006377  
Inspection date: 14 Apr 2026

Manufacturer: Skoda  
VIN: TMBJJ8NX0PY076190

Model: Octavia Combi 2.0 TDI DSG Tour

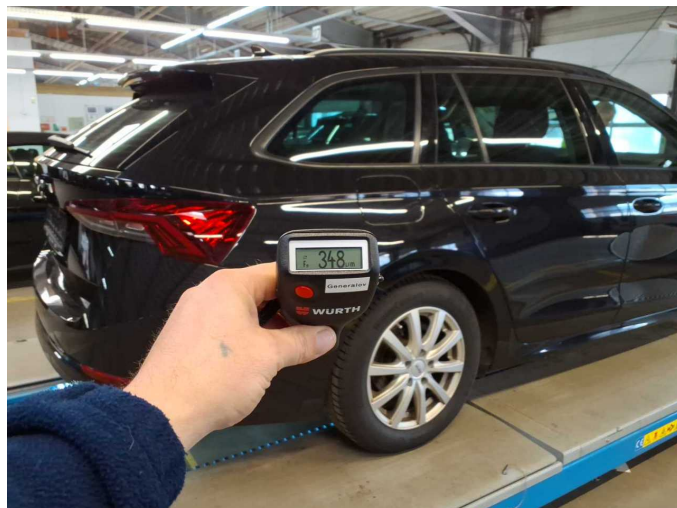
**Repainting 2:** Side panel - rear right side
