Expertise

Protocol number: 46341519
Order No. / Reference: 26595562
Inspection date: 2 Jul 2026

Manufacturer: Peugeot

Model: 208 Elektromotor 136 Allure

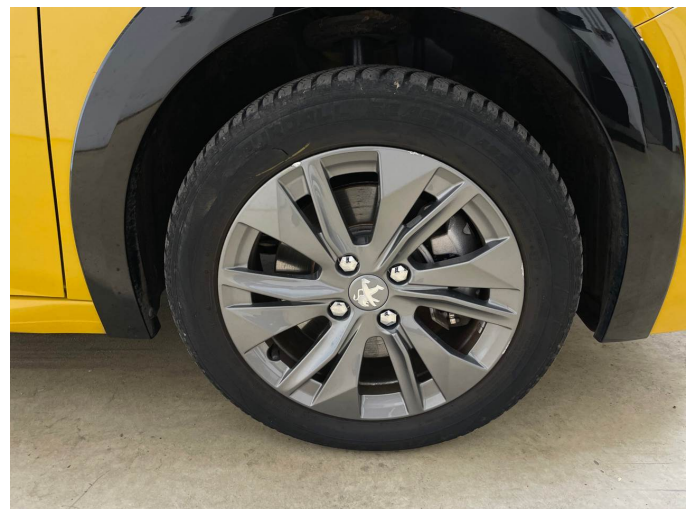
Figure 12: Mounted tyres

#	Tyre size	Type of tyre	Manufacturer	Tread depth
1)	195/55 R16 87V	All-season tyres on Light alloy	Falken	6mm / 4mm
2)	195/55 R16 87V	All-season tyres on Light alloy	Falken	6mm / 6mm

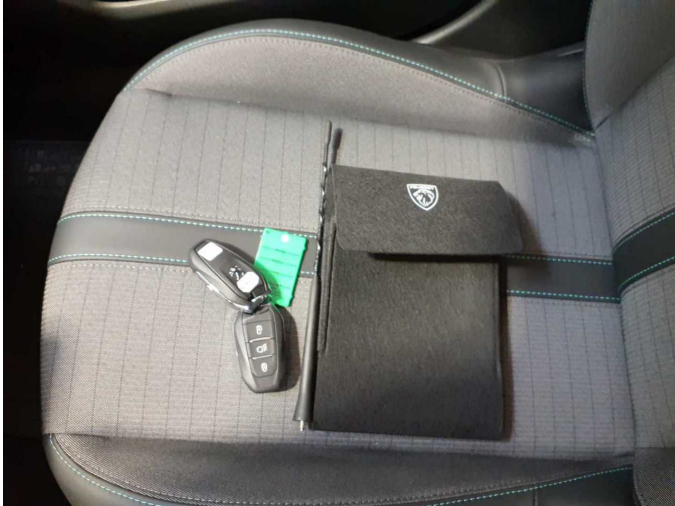
Figure 13: Documents

Documents submitted	At the time of the inspection, the vehicle registration certificate Part 2 (title) was available, but the vehicle registration certificate Part 1 (document) was not. (Copy)
VIN comparison	The vehicle identification number (VIN) was read from the vehicle and its conformity with the submitted documents was confirmed by the undersigned during the inspection.
Inspection	The inspection conditions were sufficient for the assessment of the vehicle. No lifting equipment or pit was available for inspecting the vehicle. Therefore, inspection of the vehicle's underside was only possible to a limited extent.
Test drive	No test drive/shunting maneuver was carried out during the inspection of the vehicle.
Engine function test	An engine test run was performed.
