Expertise

Protocol number: 46879977  
Order No. / Reference: 26765631  
Inspection date: 4 Aug 2026

Manufacturer: Toyota

Model: Proace City Verso 1.2 Turbo L2 Aut Team Deutschland

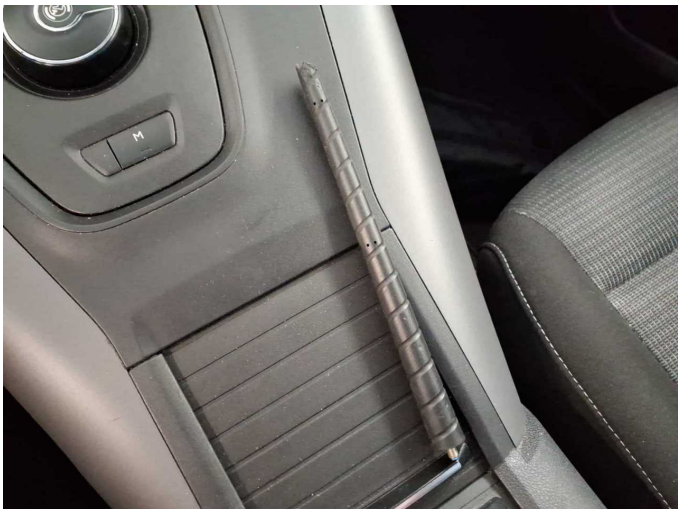
| No. | Component group | Description |
|---|---|---|
| 1 | Roof | Stub aerial - Damage caused by marten / rodent - Replace |

Damage 1: Roof: Stub aerial - Damage caused by marten / rodent - Replace
