Expertise

Protocol number: 46711579  
Order No. / Reference: 26795010  
Inspection date: 24 Jul 2026

Manufacturer: Opel

Model: Astra Sports Tourer 1.5 D Business Edition

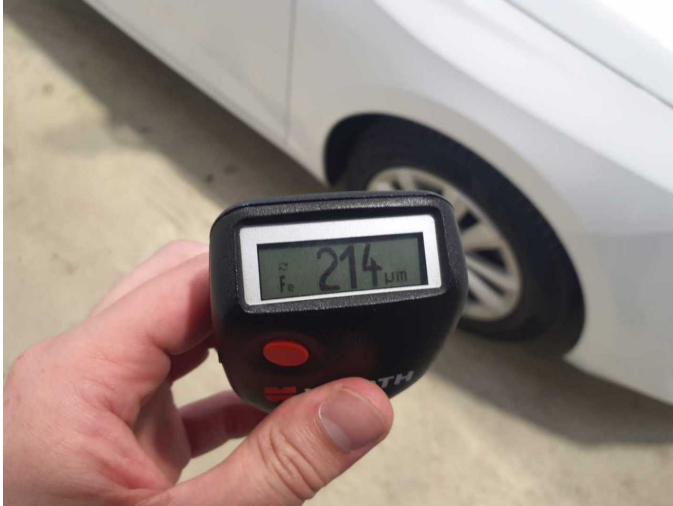
**Repainting 3:** Mudguard - right side

| No. | Component group | Description |
|---|---|---|
| 9 | Mudguard - right side | Mudguard - right side (Wellig und lack löst sich) - Unprofessionally repaired - Paint |

| No. | Repainting |
|---|---|
| 3 | Mudguard - right side, Unprofessionally carried out, Invoice of repair done Non-existent |
