Expertise

Protocol number: 45582237
Order No. / Reference: 26381404
Inspection date: 22 May 2026

Model: Kodiaq 2.0 TDI 4x4 DSG Style

VIN: TMBLN9NS6P8523208

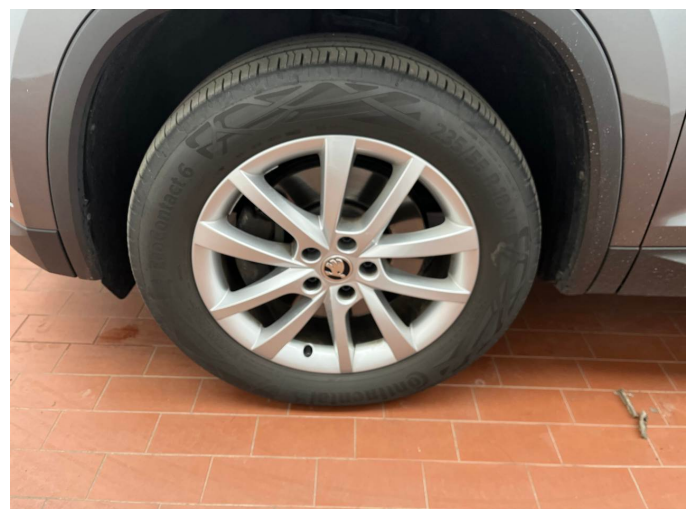
Figure 12: Mounted tyres

Mounted tyres				
#	Tyre size	Type of tyre	Manufacturer	Tread depth
1)	235/55 R18 100V	Summer tyres on Light alloy	Continental	5mm / 5mm
2)	235/55 R18 100V	Summer tyres on Light alloy	Continental	6mm / 6mm
Additional tyres				
#	Tyre size	Type of tyre	Manufacturer	Tread depth
1)	235/55 R18 104H	Winter tyres on Light alloy	Pirelli	5mm / 5mm
2)	235/55 R18 104H	Winter tyres on Light alloy	Pirelli	6mm / 6mm
Replacement				
Typ	Tyre size	Type of tyre	Manufacturer	Tread depth
	Tirefit	Expiration date 01/2027
