Expertise

Protocol number: 44909409
Order No. / Reference: 25987366
Inspection date: 31 Mar 2026

Manufacturer: Opel

Model: Movano 2.2 D L3H2 2WD VA Edition

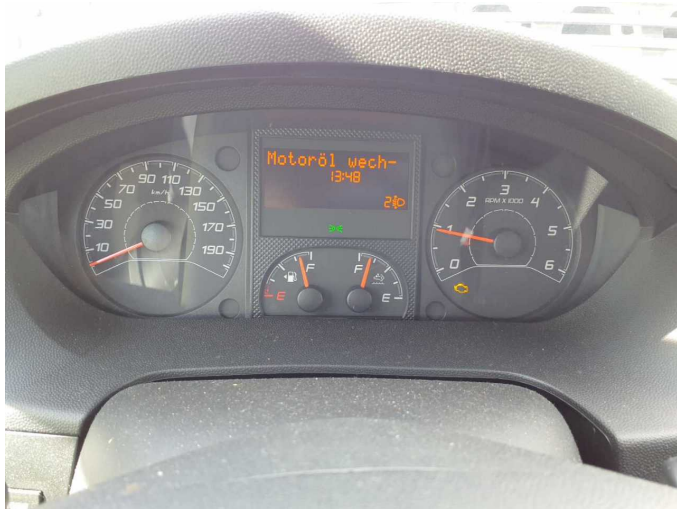
Figure 7: Instrument cluster

Documents submitted	At the time of the inspection, the vehicle registration certificate Part 2 (title) was available, but the vehicle registration certificate Part 1 (document) was not. (Copy)
VIN comparison	The vehicle identification number (VIN) was read from the vehicle and its conformity with the submitted documents was confirmed by the undersigned during the inspection.
Inspection	A proper visual inspection of the paintwork and bodywork was only possible to a limited extent due to insufficient lighting conditions/dampness or dirt. No lifting equipment or pit was available for inspecting the vehicle. Therefore, inspection of the vehicle's underside was only possible to a limited extent.
Test drive	No test drive/shunting maneuver was carried out during the inspection of the vehicle.
Engine function test	An engine test run was performed, problem has been detected This is due to the following reason: Motorkontrolleuchte und Öldruckleuchte

- Fahrzeug nicht fahrbereit, Verdacht auf Motorschaden.
