Expertise

Protocol number: 46064952
Order No. / Reference: 26546740
Inspection date: 22 Jun 2026

Manufacturer: MAN

Model: TGE 3.140 4X2F SB

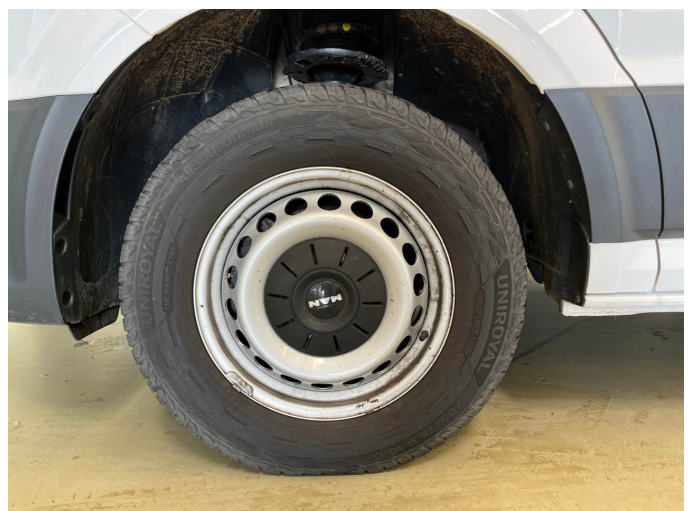
Figure 12: Mounted tyres

#	Tyre size	Type of tyre	Manufacturer	Tread depth
1)	205/75 R16 110R	All-season tyres on Steel rim with wheel cover	Uniroyal	6mm / 6mm
2)	205/75 R16 113R	All-season tyres on Steel rim with wheel cover	Continental	6mm / 6mm
