Expertise

Protocol number: 46230783
Order No. / Reference: 26571336
Inspection date: 29 Jun 2026

Manufacturer: Ford

Model: Transit 350 L3H3 Lkw VA Trend

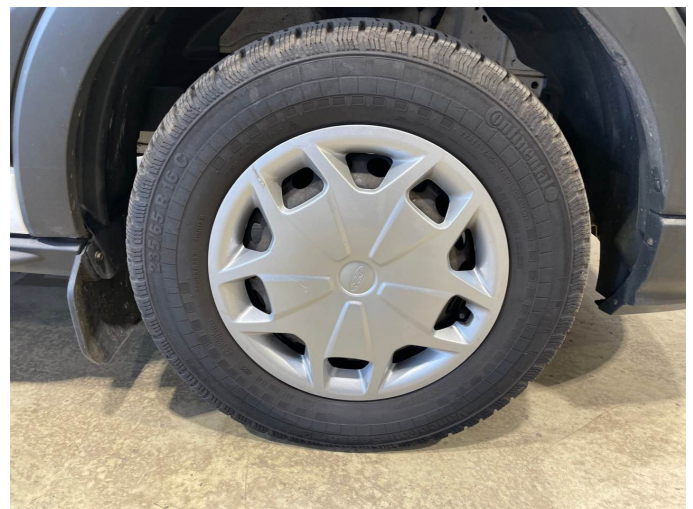
Figure 12: Mounted tyres

Mounted tyres				
#	Tyre size	Type of tyre	Manufacturer	Tread depth
1)	235/65 R16 115R	All-season tyres on Steel rim with wheel cover	Continental	5mm / 5mm
2)	235/65 R16 115S	All-season tyres on Steel rim with wheel cover	Goodyear	3mm / 3mm
