Expertise

Protocol number: 46201181
Order No. / Reference: 26154565
Inspection date: 17 Jun 2026

Model: 317 CDI Sprinter Lang HA 9G-TRONIC PRO

VIN: W1V3KCFZ5TP845171

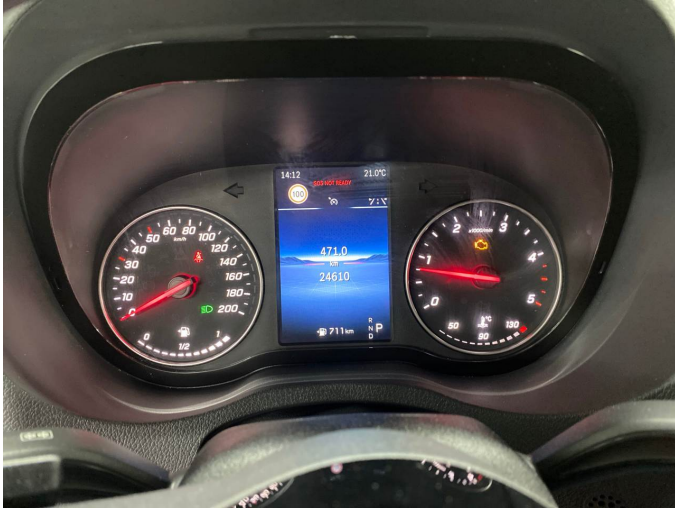
Figure 7: Instrument cluster

Documents submitted	At the time of the inspection, the vehicle registration certificate Part 2 (title) was available, but the vehicle registration certificate Part 1 (document) was not. (Copy)
VIN comparison	The vehicle identification number (VIN) was read from the vehicle and its conformity with the submitted documents was confirmed by the undersigned during the inspection.
Inspection	The inspection conditions were sufficient for the assessment of the vehicle. Lifting equipment and/or a pit were available for examining the vehicle.
Test drive	No test drive/shunting maneuver was carried out during the inspection of the vehicle.
Engine function test	An engine test run was performed, problem has been detected This is due to the following reason.: Motorkontrolleuchte aktiv

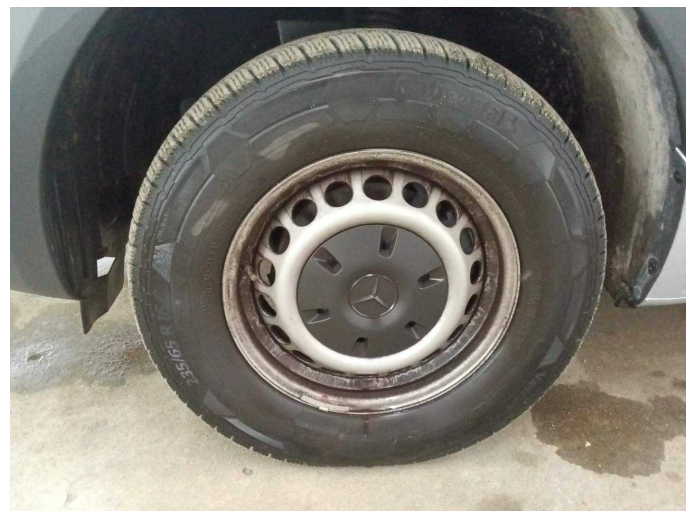
Figure 12: Mounted tyres

#	Tyre size	Type of tyre	Manufacturer	Tread depth
1)	235/65 R16 121R	Winter tyres on Steel rim with wheel cover	Continental	8mm / 8mm
2)	235/65 R16 121R	Winter tyres on Steel rim with wheel cover	Continental	7mm / 7mm
