## Expertise

Protocol number: 45585933  
Order No. / Reference: 26292872  
Inspection date: 13 May 2026

Model: Vito 116 CDI Extralang HA Aut. PRO

VIN: W1VVLCEZXT4565643

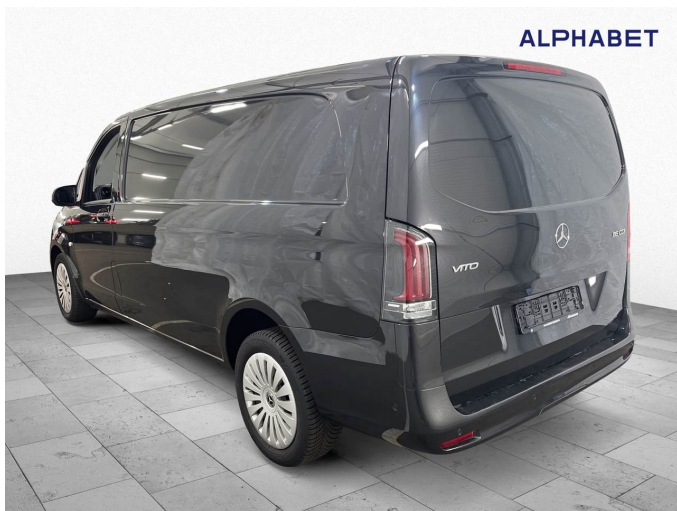
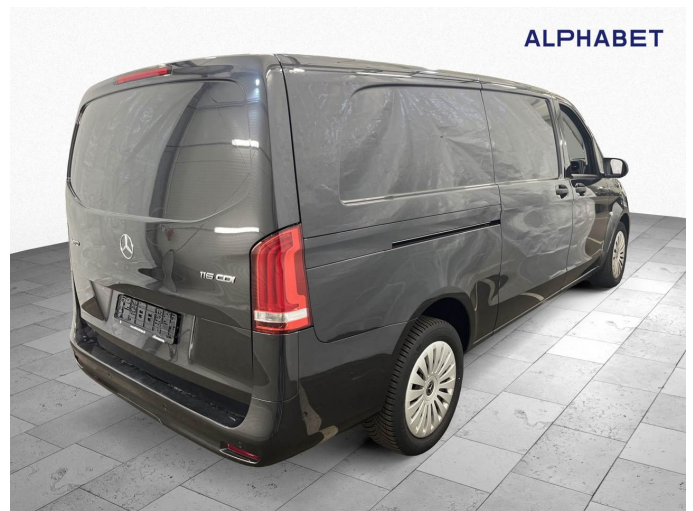
No.	Component group	Description
1	Misc.	Inspection / maintenance - No evidence - No deduction
2	Misc.	Main inspection - No evidence - No deduction
3	Boot lid / rear door	Boot lid - dent(s) - Repair and paint
