## Expertise

Protocol number: 46023893  
Order No. / Reference: 26410573-1  
Inspection date: 18 Jun 2026

Model: Trafic Blue dCi 170 EDC Grand Spaceclass

VIN: VF1JL000971193019

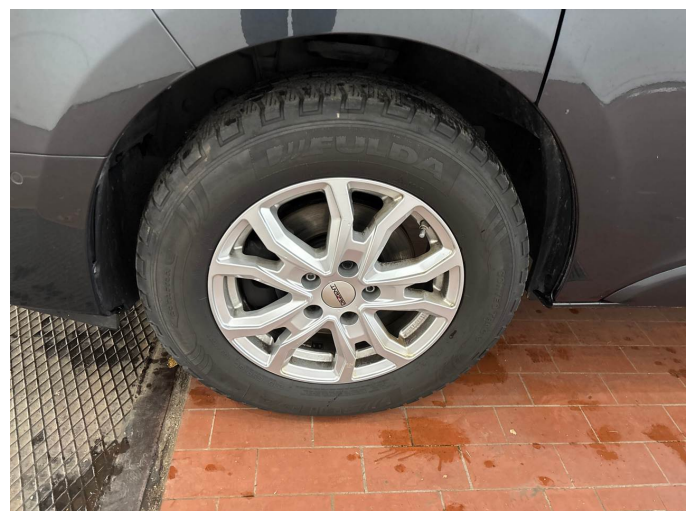
Figure 12: Mounted tyres

- Für den montierten Radsatz lag zum Besichtigungszeitpunkt kein Nachweis über die Zulässigkeit vor.
