## Expertise

Protocol number: 45982517  
Order No. / Reference: 26499407  
Inspection date: 16 Jun 2026

Manufacturer: Peugeot

Model: 2008 BlueHDi 130 EAT8 Allure

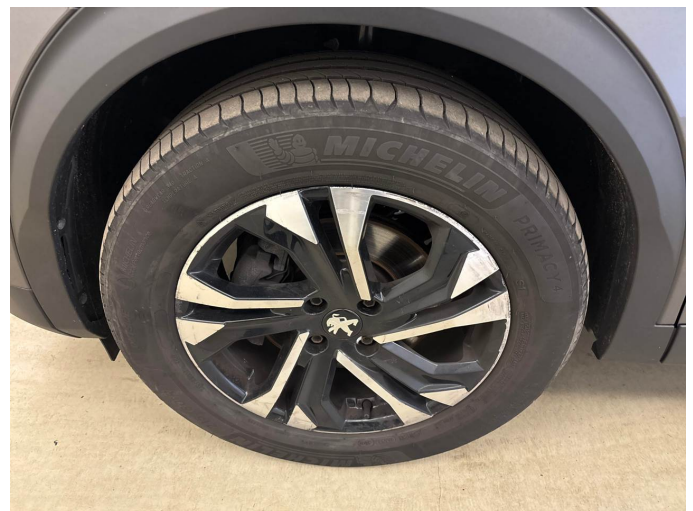
#	Tyre size	Type of tyre	Manufacturer	Tread depth
1)	215/60 R17 96H	Summer tyres on Light alloy	Michelin	4mm / 4mm
2)	215/60 R17 96H	Summer tyres on Light alloy	Michelin	4mm / 4mm

Figure 12: Mounted tyres
