Expertise

Protocol number: 46294940
Order No. / Reference: MW3041570
Inspection date: 30 Jun 2026

Manufacturer: Renault

Model: Kangoo Maxi Z.E. 33 (mit Batterie)

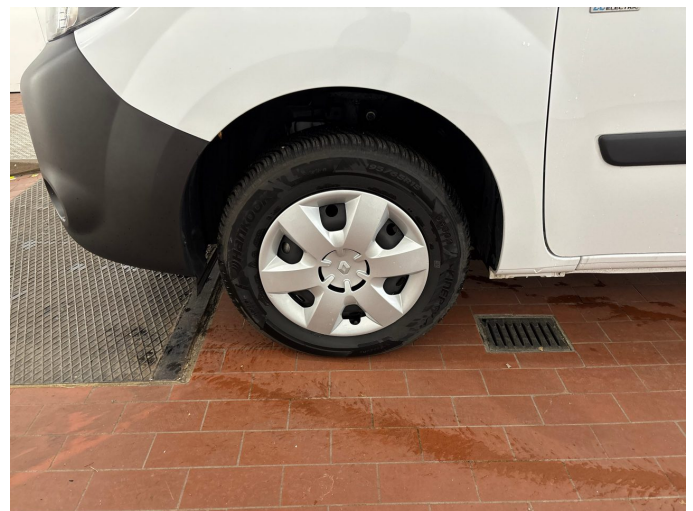
Figure 12: Mounted tyres

#	Tyre size	Type of tyre	Manufacturer	Tread depth
1)	195/65 R15 95H	All-season tyres on Steel rim with wheel cover	Hankook	5mm / 5mm
2)	195/65 R15 95H	All-season tyres on Steel rim with wheel cover	Hankook	6mm / 6mm
