## Expertise

Protocol number: 46292724  
Order No. / Reference: 26512448  
Inspection date: 1 Jul 2026

Manufacturer: Ford

Model: Mondeo Turnier 2.0 EcoBlue Titanium

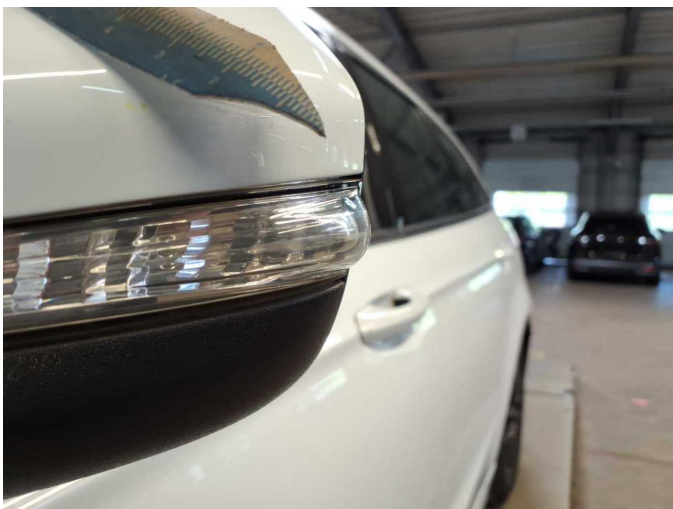
**Damage 10:** Indicator - front: Mirror - left side (Materialabtrag) - Scratch(es) - Replace

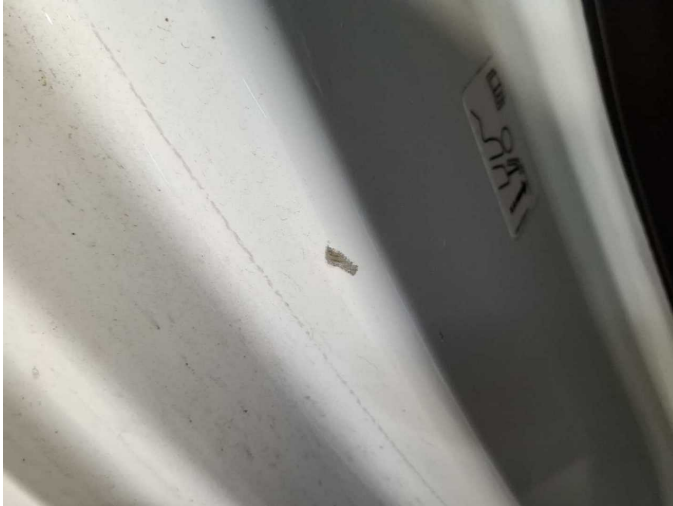
**Damage 12:** Side panel - rear right side: Sill - Dent / paintcoat damage - Smart repair

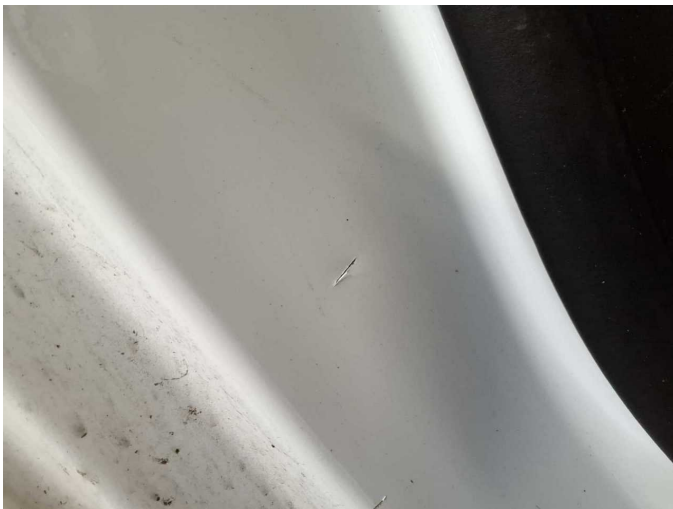
**Damage 12:** Side panel - rear right side: Sill - Dent / paintcoat damage - Smart repair

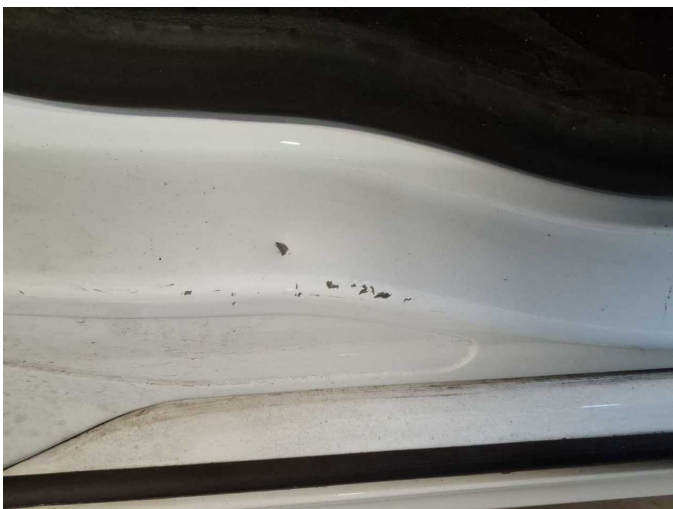
**Damage 12:** Side panel - rear right side: Sill - Dent / paintcoat damage - Smart repair

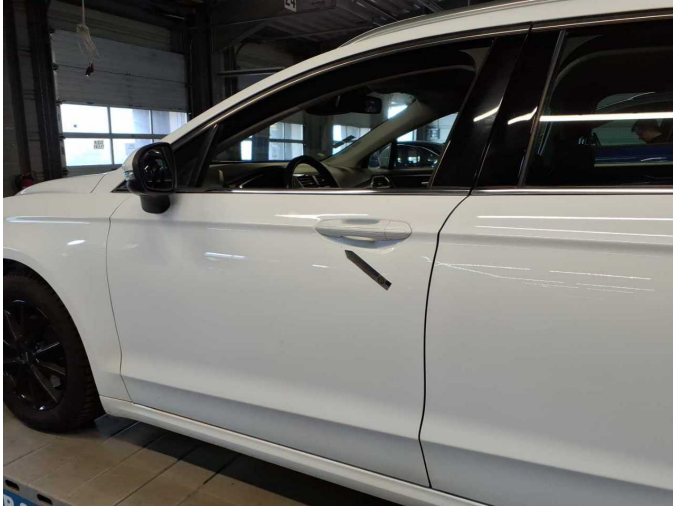
**Damage 17:** Door - front left side: Door - Dent / paintcoat damage - Repair and paint

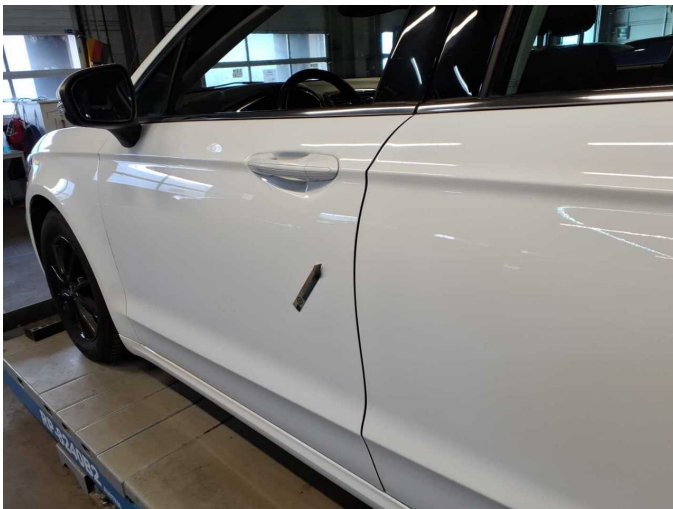
**Damage 17:** Door - front left side: Door - Dent / paintcoat damage - Repair and paint

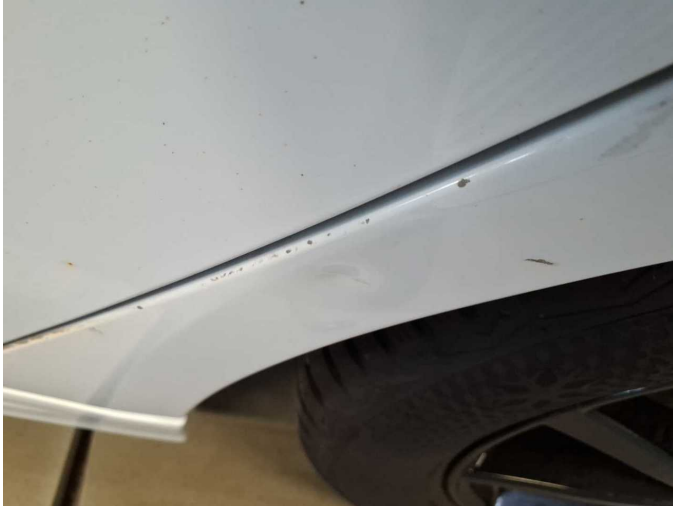
**Damage 18:** Side panel - rear left side: Side panel - Dent / paintcoat damage - Repair and paint

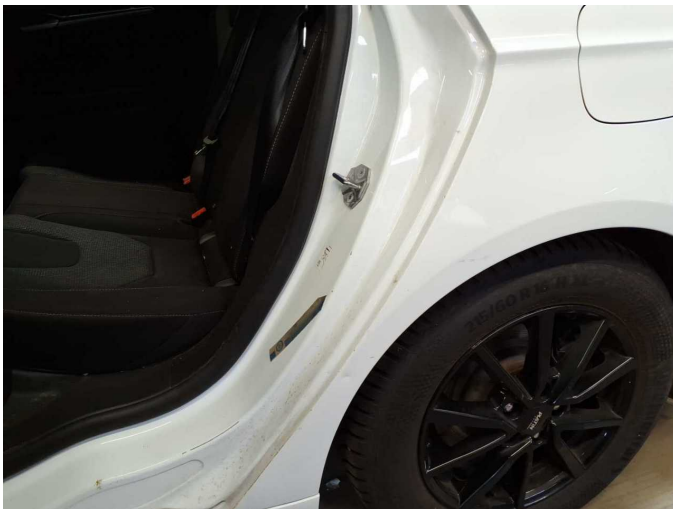
**Damage 18:** Side panel - rear left side: Side panel - Dent / paintcoat damage - Repair and paint

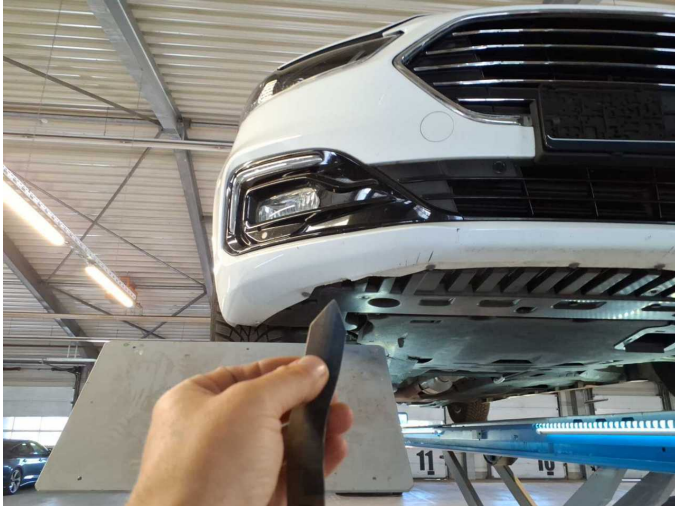
**Damage 19:** Front bumper: Front bumper (Verformt) - Scratched - Repair and paint
