Expertise

Protocol number: 44042954
Order number / reference: 26060496
Inspection date: 23 Feb 2026

Model: Vito 116 CDI Extralang HA Aut. PRO

VIN: W1VVLCEZ5T4564030

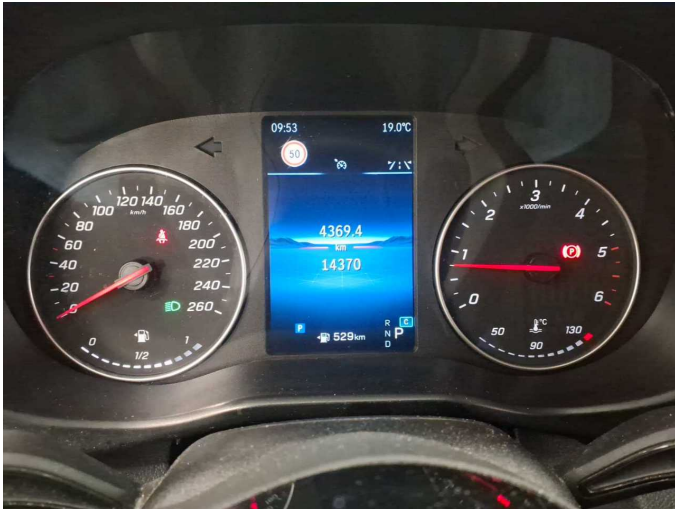
Figure 7: Instrument cluster

Mileage (Read) 14,370 km

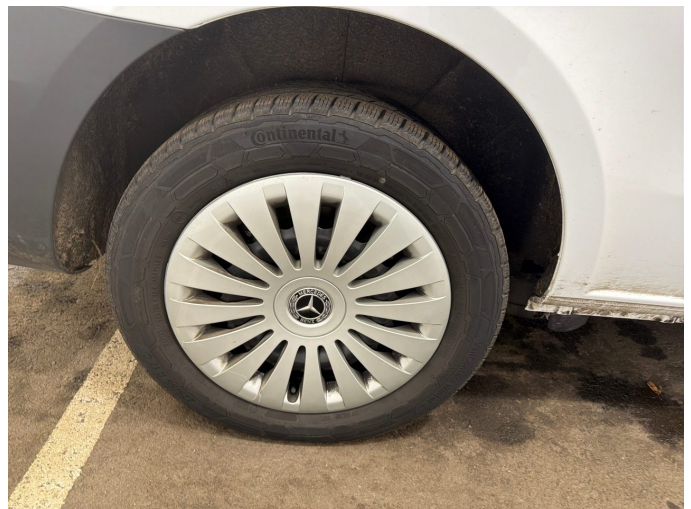
Figure 12: Mounted tyres

#	Tyre size	Type of tyre	Manufacturer	Tread depth
1)	225/55 R17 109T	Winter tyres on Steel rim with wheel cover	Continental	5mm / 5mm
2)	225/55 R17 109T	Winter tyres on Steel rim with wheel cover	Continental	5mm / 5mm
