Expertise

Protocol number: 45485295
Order No. / Reference: 26234949
Inspection date: 11 May 2026

Manufacturer: Toyota

Model: Proace 2,0-I-D-4D L1 Comfort

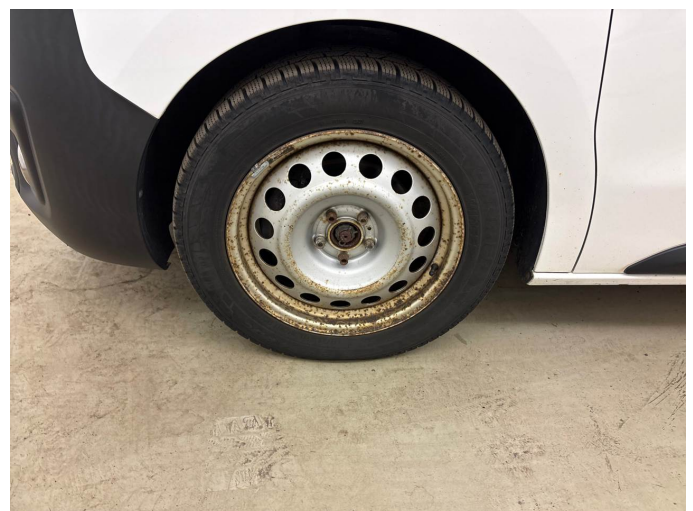
Figure 12: Mounted tyres

#	Tyre size	Type of tyre	Manufacturer	Tread depth
1)	215/60 R17 107T	Winter tyres on Steel	Pirelli	6mm / 6mm
2)	215/60 R17 107T	Winter tyres on Steel	Pirelli	7mm / 7mm
