Expertise

Protocol number: 46351642
Order No. / Reference: 26521714
Inspection date: 7 Jul 2026

Model: Octavia Combi 2.0 TDI Ambition

VIN: TMBJG7NX4NY051072

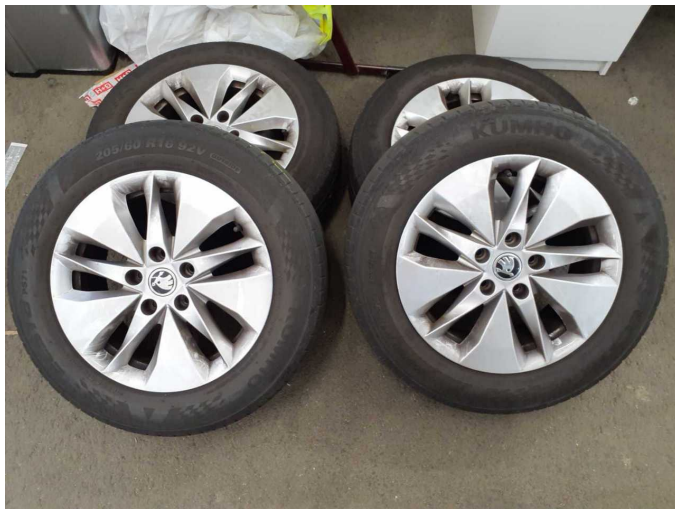
Figure 15: Additional tyres

#	Tyre size	Type of tyre	Manufacturer	Tread depth
1)	205/60 R16 92V	Summer tyres on Light alloy	Kumho	4mm / 4mm
2)	205/60 R16 92V	Summer tyres on Light alloy	Kumho	4mm / 4mm

Typ	Tyre size	Type of tyre	Manufacturer	Tread depth
	Tirefit	Expiration date 09/2025
