Expertise

Protocol number: 46316514  
Order No. / Reference: 26533188  
Inspection date: 3 Jul 2026

Manufacturer: Opel

Model: Astra Sports Tourer 1.5 D Business Elegance

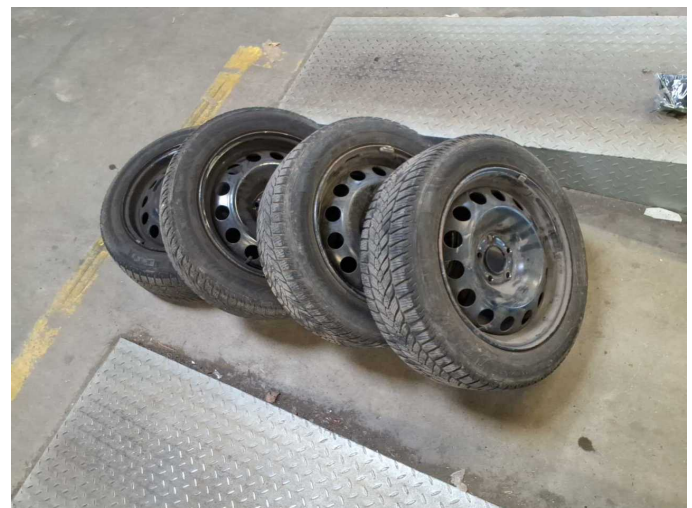
Figure 16: Additional tyres

| No. | Component group | Description |
|---|---|---|
| 5 | 2nd wheel set | 1 tyre (Rest über 4mm.) - Does not meet the leasing specifications - Replace |
