Expertise

Protocol number: 46661667  
Order No. / Reference: 26644465  
Inspection date: 22 Jul 2026

Manufacturer: Skoda  
VIN: TMBJH9NP2M7075108

Model: Superb Combi 2.0 TDI Ambition

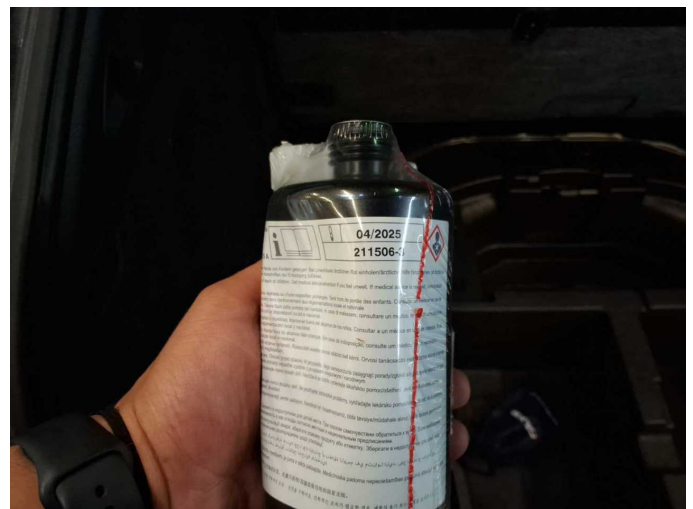
| No. | Component group | Description |
|---|---|---|
| 1 | Equipment | Tirefit filler - Expired - Replace |

Damage 1: Equipment: Tirefit filler - Expired - Replace
