## Expertise

Protocol number: 46130548  
Order No. / Reference: 26496406  
Inspection date: 22 Jun 2026

Manufacturer: Skoda

Model: Enyaq iV 80

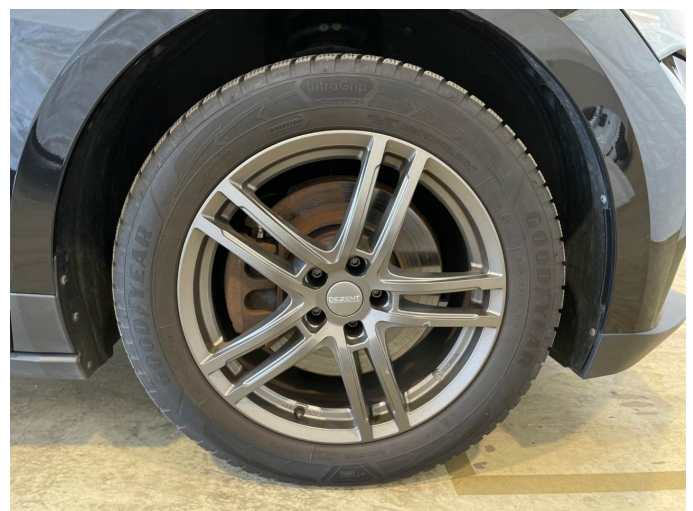
Figure 12: Mounted tyres

Mounted tyres				
#	Tyre size	Type of tyre	Manufacturer	Tread depth
1)	235/55 R19 105T	Winter tyres on Light alloy	Goodyear	7mm / 7mm
2)	255/50 R19 107T	Winter tyres on Light alloy	Goodyear	6mm / 6mm

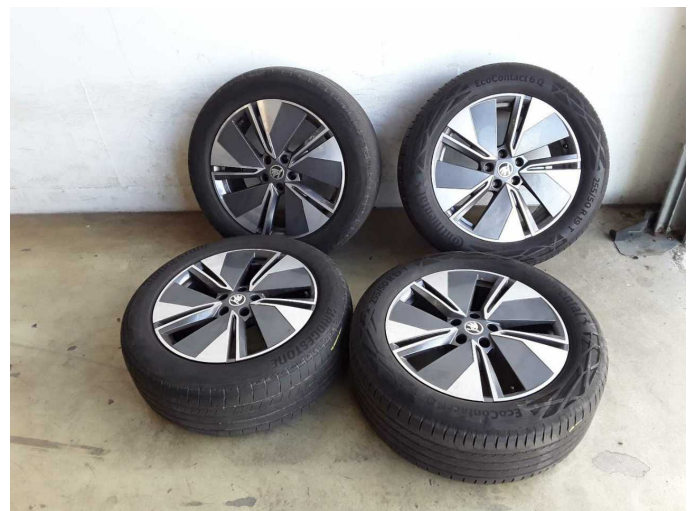
Figure 16: Additional tyres

Additional tyres				
#	Tyre size	Type of tyre	Manufacturer	Tread depth
1)	235/55 R19 101T	Summer tyres on Light alloy	Bridgestone	4mm / 4mm
2)	255/50 R19 103T	Summer tyres on Light alloy	Continental	5mm / 5mm
