**TMAK381GFMJ034668**

## Zustandsbericht

Besichtigungsdatum: 09.06.2026  
**Protokollnummer: 45840868**  
Erstellt durch: Paula Kube  
Besichtigt durch: Paula Kube

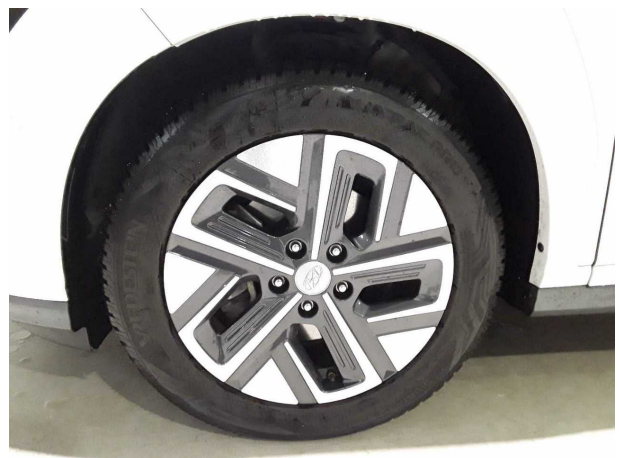
Abbildung 6: Montierte Bereifung

Der Verschleißzustand sowie evtl. Schäden an der Bereifung sind wertmäßig berücksichtigt.
