Expertise

Protocol number: 46791414  
Order No. / Reference: 26777074  
Inspection date: 27 Jul 2026

Manufacturer: Kia

Model: Ceed SW 1.6 CRDi (48V Mild-Hybrid) Vision

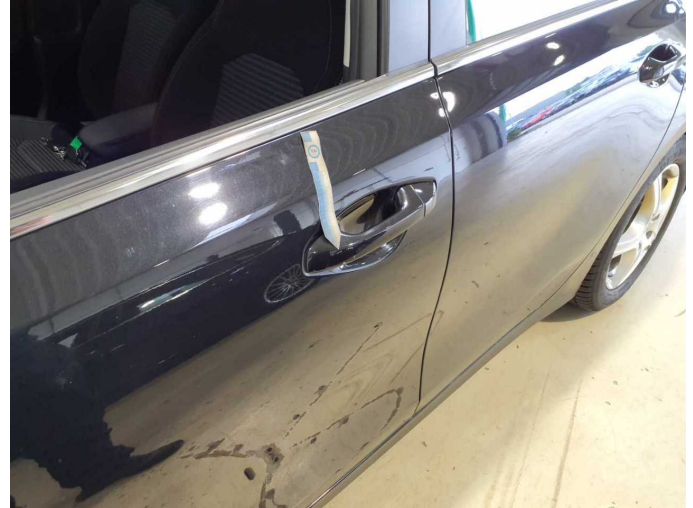
| No. | Component group | Description |
|---|---|---|
| 1 | Door - front left side | Door handle - outside - Scratch(es) - Smart repair |

**Damage 1:** Door - front left side: Door handle - outside - Scratch(es) - Smart repair

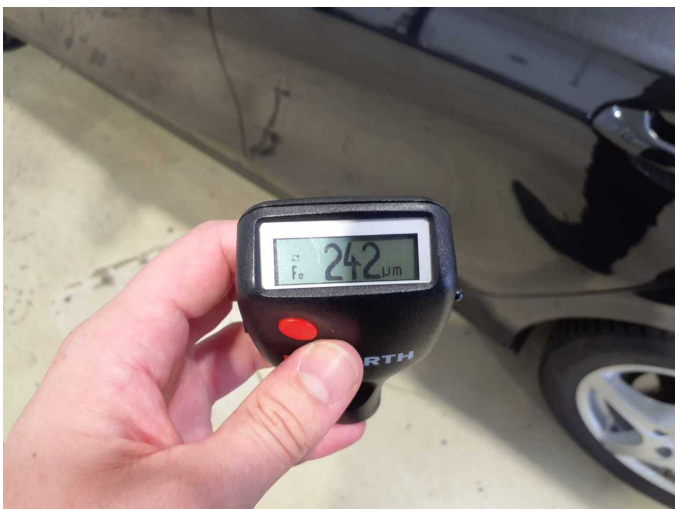
1 Door - rear left side, Professionally carried out, Invoice of repair done Non-existent

**Repainting 1:** Door - rear left side
