## Expertise

Protocol number: 46181648  
Order No. / Reference: 26554469  
Inspection date: 24 Jun 2026

Model: Astra 1.5 D Start/Stop Sports Tourer Automatik Business  
Elegance

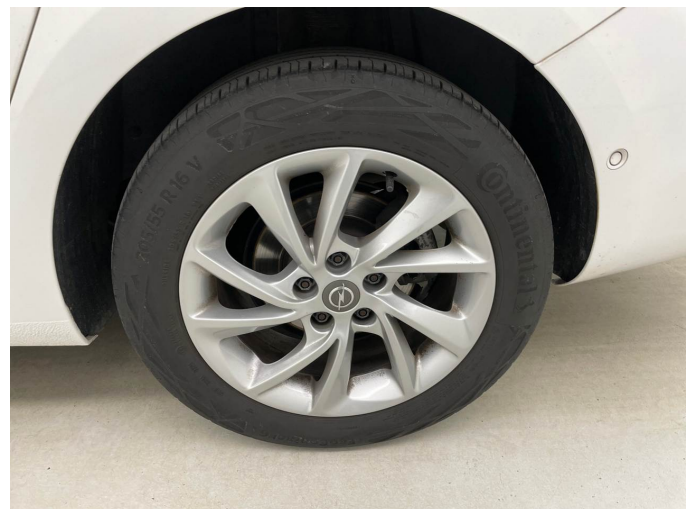
Figure 12: Mounted tyres

#	Tyre size	Type of tyre	Manufacturer	Tread depth
1)	205/55 R16 91V	Summer tyres on Light alloy	Continental	5mm / 5mm
2)	205/55 R16 91V	Summer tyres on Light alloy	Continental	4mm / 4mm
