## Expertise

Protocol number: 45566700  
Order No. / Reference: 26351944  
Inspection date: 18 May 2026

Model: Focus Turnier 2.0 EcoBlue Start-Stopp-System Aut.  
COOL&CONNECT

VIN: WF0PXXGCHPLK11797

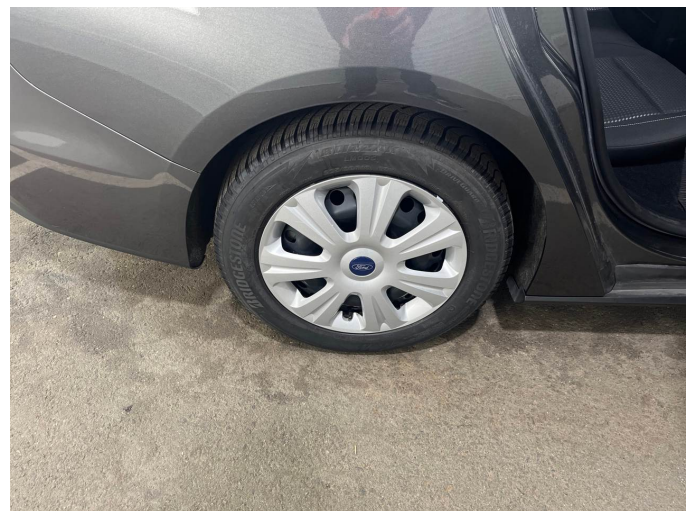
Figure 12: Mounted tyres

#	Tyre size	Type of tyre	Manufacturer	Tread depth
1)	205/60 R16 96H	Winter tyres on Steel rim with wheel cover	Bridgestone	5mm / 5mm
2)	205/60 R16 96H	Winter tyres on Steel rim with wheel cover	Bridgestone	2mm / 2mm
