## Expertise

Protocol number: 46199646  
Order No. / Reference: 26154059  
Inspection date: 16 Jun 2026

Model: Vito 116 CDI Tourer Lang Aut. PRO

VIN: W1VVLFEZ9T4555834

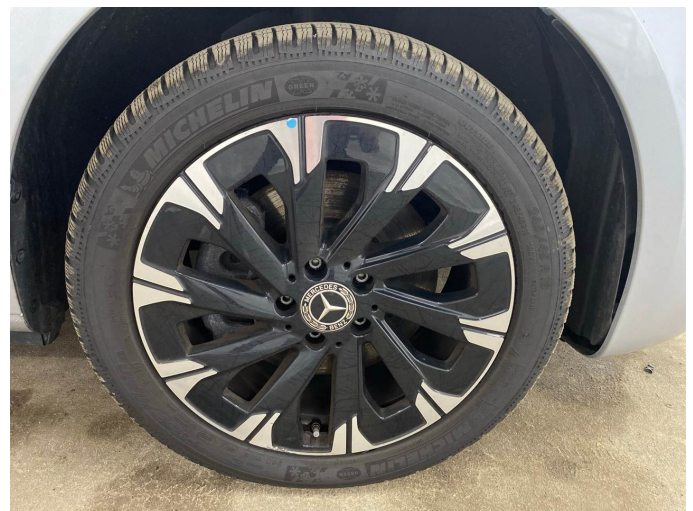
Figure 12: Mounted tyres

#	Tyre size	Type of tyre	Manufacturer	Tread depth
1)	245/45 R18 100V	Winter tyres on Light alloy	Michelin	7mm / 7mm
2)	245/45 R18 100V	Winter tyres on Light alloy	Michelin	6mm / 6mm
