# INSPECTION REPORT

**End of contract**

| License plate | 2DSE985 |
| Make | Ford Kuga 2.5i EB 165kW ST-Lin |

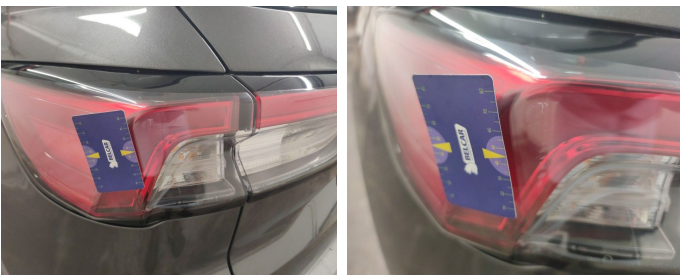
| Damages | Type | Acceptable |
|---|---|---|
| 124 | Light / Rear left / Replace | N |

Light / Rear left / Replace-scratch
