Expertise

Protocol number: 46193336
Order No. / Reference: 25933026
Inspection date: 21 May 2026

Manufacturer: Mercedes-Benz

Model: Vito 116 CDI Lang HA Aut. PRO

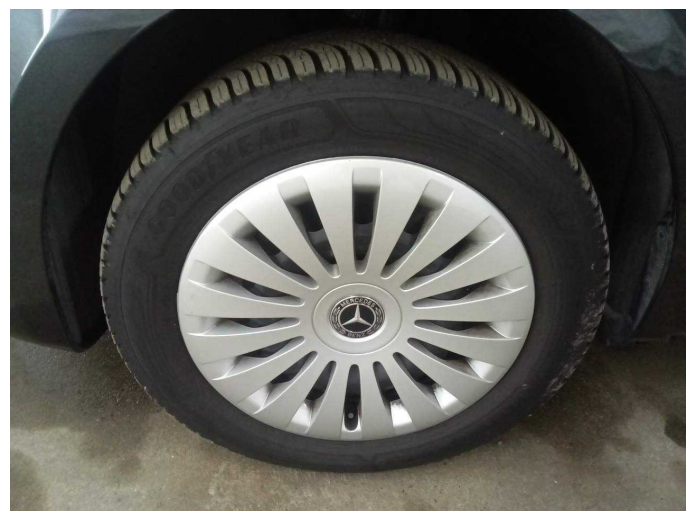
Figure 12: Mounted tyres

#	Tyre size	Type of tyre	Manufacturer	Tread depth
1)	225/55 R17 109H	All-season tyres on Steel rim with wheel cover	Goodyear	8mm / 8mm
2)	225/55 R17 109H	All-season tyres on Steel rim with wheel cover	Goodyear	8mm / 8mm
