Expertise

Protocol number: 46605981  
Order No. / Reference: 26701943  
Inspection date: 20 Jul 2026

Manufacturer: Volkswagen  
VIN: WVGZZCD1PW513507

Model: Golf Variant 2.0 TDI SCR DSG Style

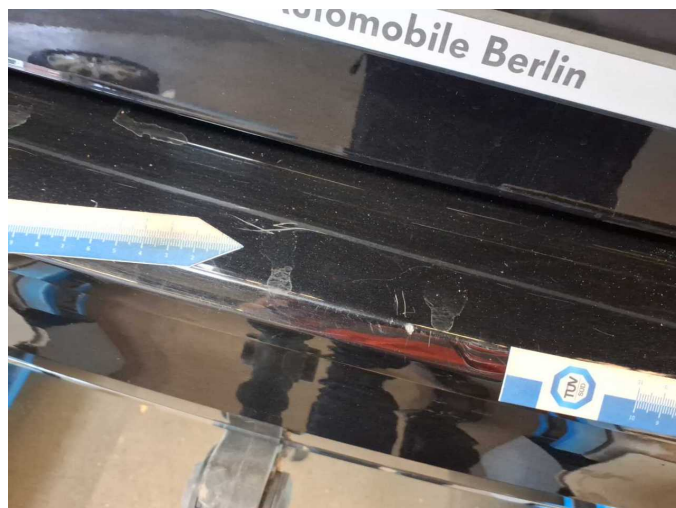
**Damage 17:** Rear bumper: Rear bumper - Scratch(es) - Paint
