Expertise

Protocol number: 46400602  
Order No. / Reference: 26640149  
Inspection date: 8 Jul 2026

Manufacturer: Opel

Model: Astra 1.5 D Automatik Business Elegance

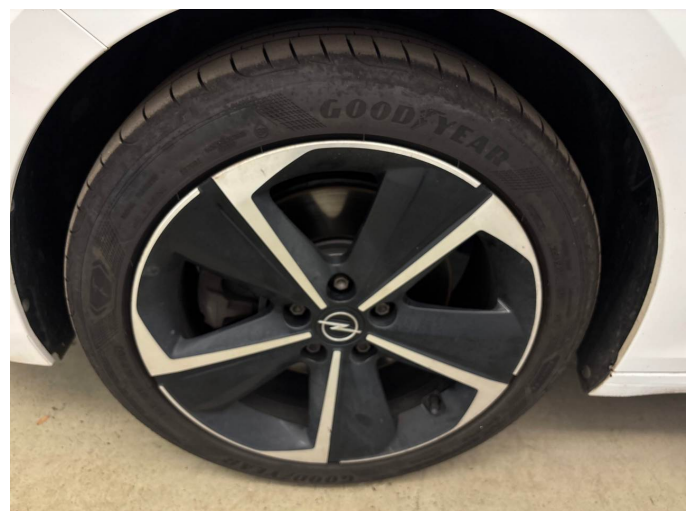
Figure 12: Mounted tyres

| # | Tyre size | Type of tyre | Manufacturer | Tread depth |
|---|---|---|---|---|
| 1) | 225/45 R17 94V | Summer tyres on Light alloy | Michelin | 4mm / 4mm |
| 2) | 225/45 R17 94V | Summer tyres on Light alloy | Michelin | 4mm / 4mm |
