Expertise

Protocol number: 46741248  
Order No. / Reference: 26639293  
Inspection date: 24 Jul 2026

Manufacturer: Ford

Model: Transit Connect 230 L2 Trend

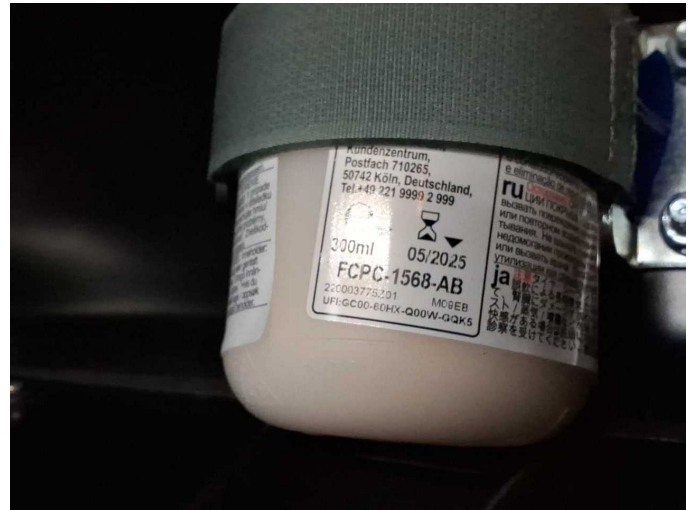
| No. | Component group | Description |
|---|---|---|
| 1 | Equipment | Tirefit filler - Expired - Replace |

Damage 1: Equipment: Tirefit filler - Expired - Replace

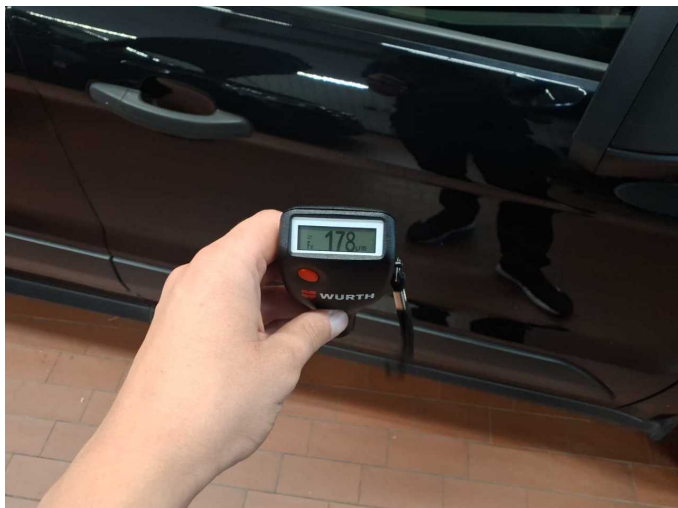
- 1 Roof, Professionally carried out, Invoice of repair done Non-existent
- 2 Door - front right side, Professionally carried out, Invoice of repair done Non-existent

**Repainting 2:** Door - front right side
