Expertise

Protocol number: 46431369  
Order No. / Reference: 26412223  
Inspection date: 9 Jul 2026

Manufacturer: Opel

Model: Combo Life 1.2 Turbo Start/Stop Edition

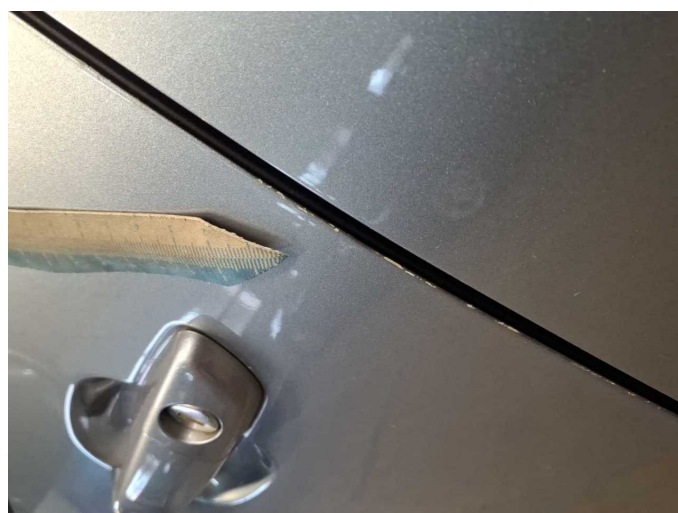
| No. | Component group | Description |
|---|---|---|
| 16 | Door - front left side | Door - Dent / paintcoat damage - Repair and paint |

**Damage 16:** Door - front left side: Door - Dent / paintcoat damage - Repair and paint

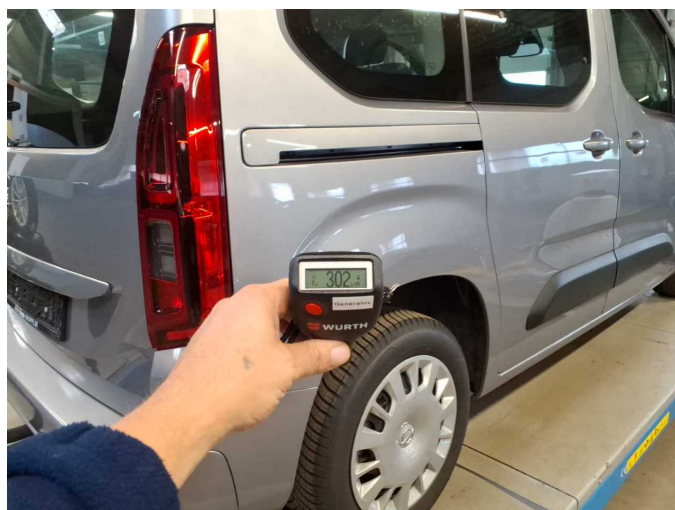
- 1 Side panel - rear right side, Professionally carried out, Invoice of repair done Non-existent
- 2 Door - front right side, Professionally carried out, Invoice of repair done Non-existent
- 3 Door - rear right side, Unprofessionally carried out, Invoice of repair done Non-existent

**Repainting 1:** Side panel - rear right side

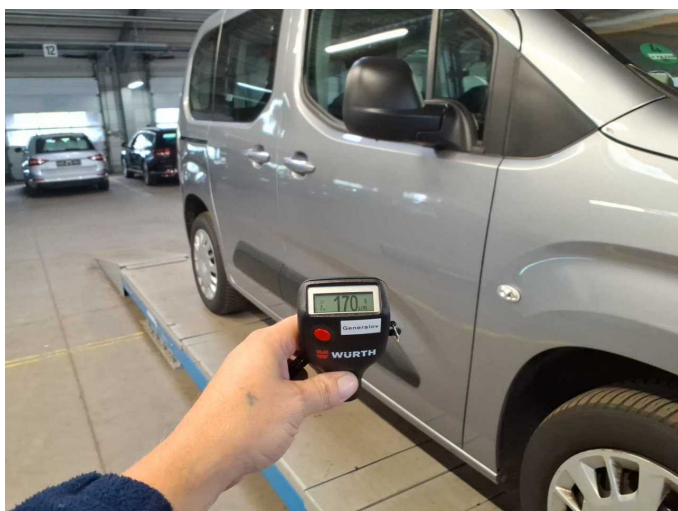
**Repainting 2:** Door - front right side

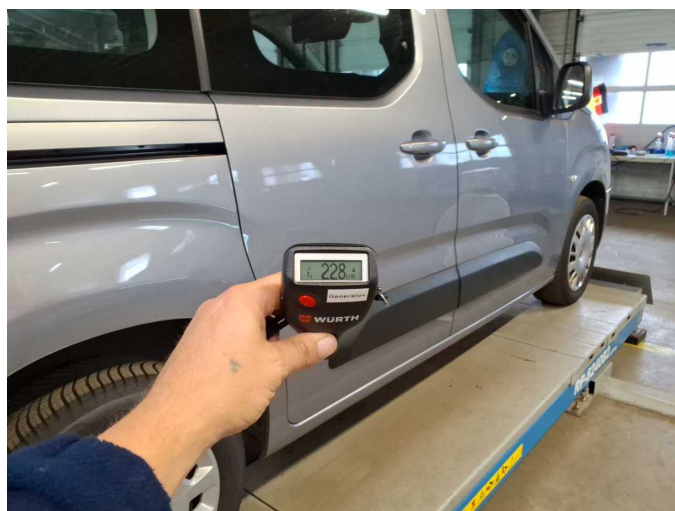
**Repainting 3:** Door - rear right side
