Expertise

Protocol number: 46497916  
Order No. / Reference: 26152024  
Inspection date: 29 Jun 2026

Manufacturer: Mercedes-Benz  
VIN: W1VVLCEZ9T4565360

Model: Vito 116 CDI Extralang HA Aut. PRO

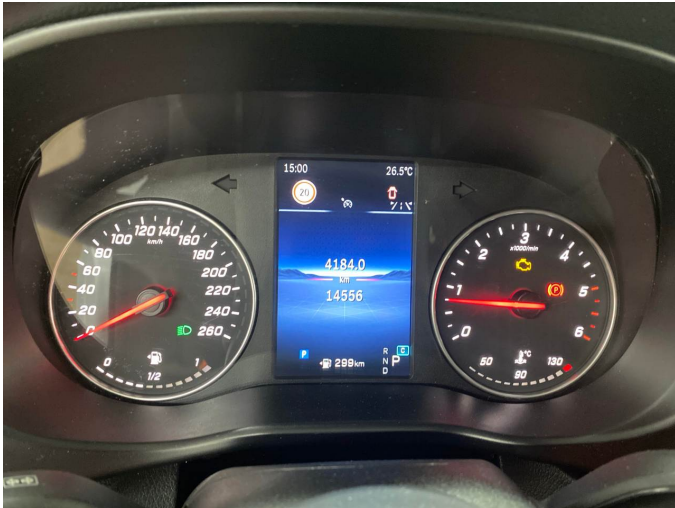
Figure 7: Instrument cluster

**Damage 3:** Instrument panel: Indicator light (Motorkontrolle) - on - Perform diagnosis

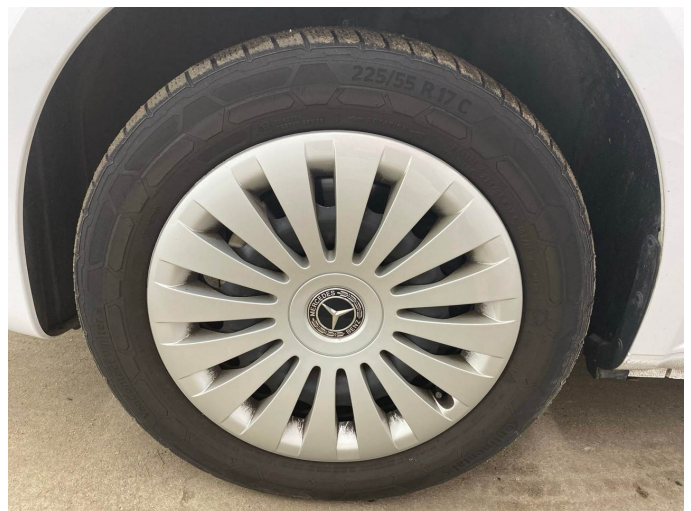
Figure 12: Mounted tyres

| No. | Component group | Description |
|---|---|---|
| 2 | Wheel / tyres | Tyre - front right side (Restlichen 3 Reifen 4,5mm) - Worn - Replace |
