Expertise

Protocol number: 47216325  
Order No. / Reference: 26861449  
Inspection date: 20 Aug 2026

Manufacturer: Opel

Model: Astra 1.5 D Start/Stop Business Edition

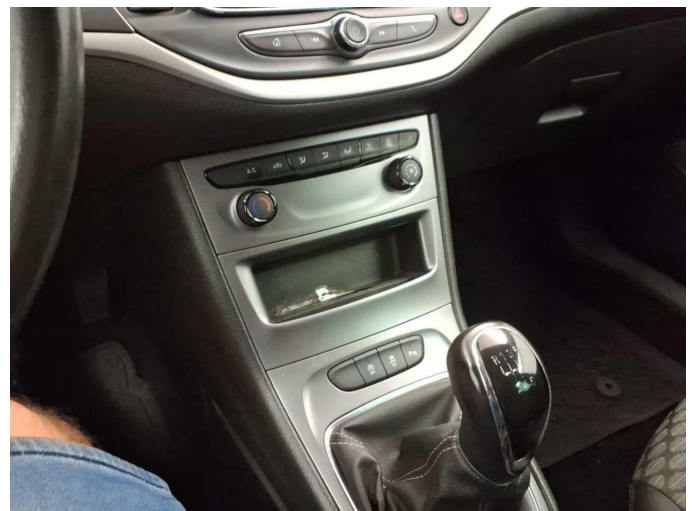
| No. | Component group | Description |
|---|---|---|
| 1 | Instrument panel | Stowage compartment (Kleberreste) - Soiled - Replace |

**Damage 1:** Instrument panel: Stowage compartment (Kleberreste) - Soiled - Replace
