## Expertise

Protocol number: 46269991  
Order No. / Reference: 26530357  
Inspection date: 26 Jun 2026

Model: Leon Sportstourer 1.5 eTSI ACT OPF DSG Xcellence

VIN: VSSZZZKLZNR001081

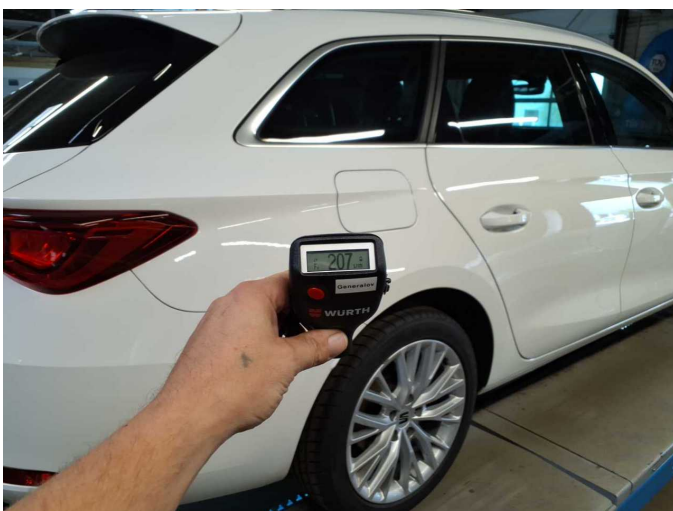
**Repainting 1:** Mudguard - right side, Side panel - rear right side, Door - rear right side, Door - front right side
