Expertise

Protocol number: 46181937
Order No. / Reference: 26242175
Inspection date: 25 Jun 2026

Model: Tiguan Allspace 2.0 TDI SCR Comfortline

VIN: WVGZZZ5NZLM160478

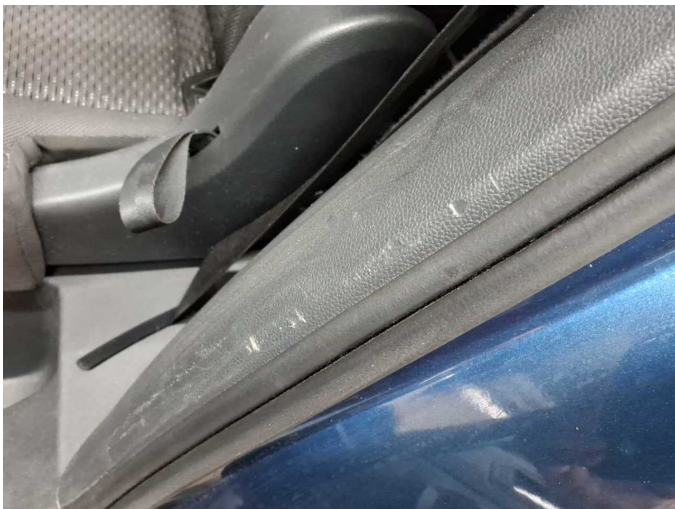
Damage 1: Side panel - rear left side: Interior trim - Scratch(es) - Loss in value

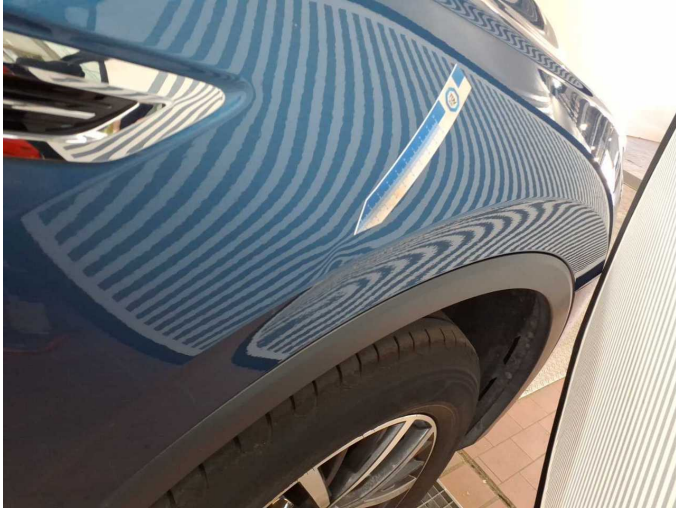
Damage 8: Mudguard - right side: Mudguard - right side - dent(s) - Smart repair

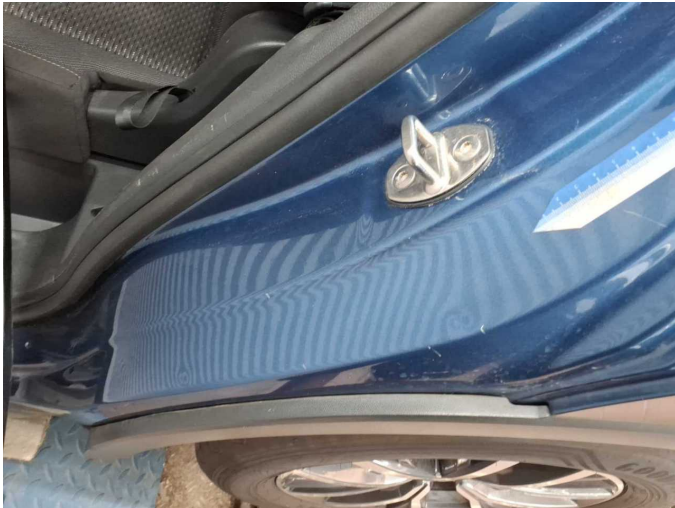
Damage 10: Side panel - rear left side: Sill - Dent / paintcoat damage - Smart repair

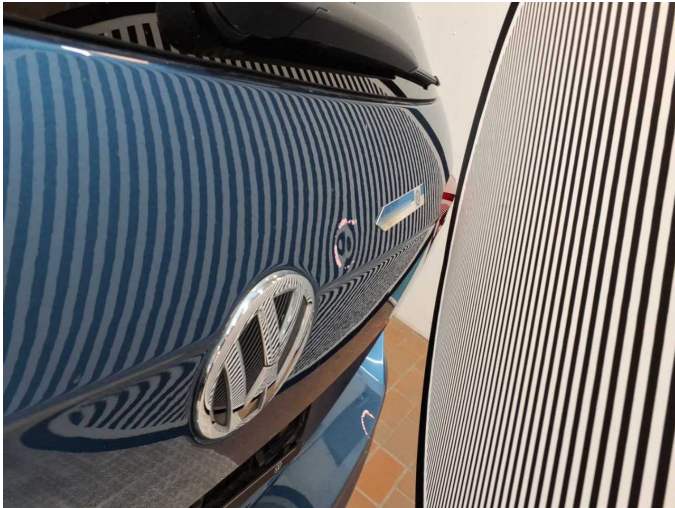
Damage 21: Boot lid / rear door: Boot lid - dent(s) - Repair and paint
