Expertise

Protocol number: 45994362
Order No. / Reference: 26472476
Inspection date: 17 Jun 2026

Manufacturer: Skoda

Model: Superb Combi 2.0 TDI DSG Style

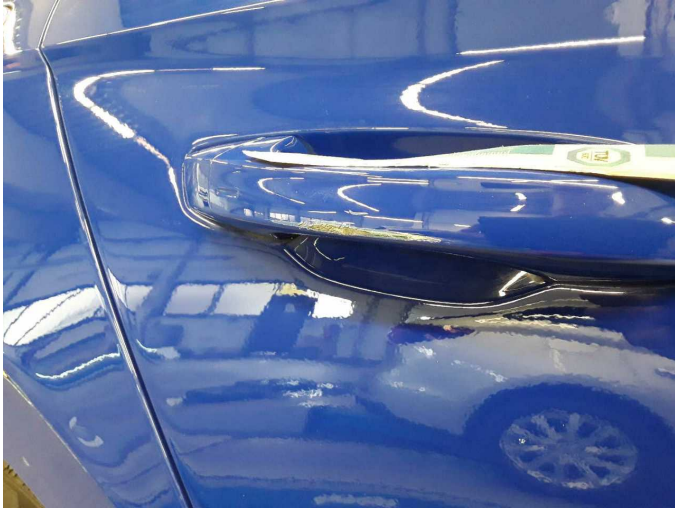
Accident 1: Front, Side right

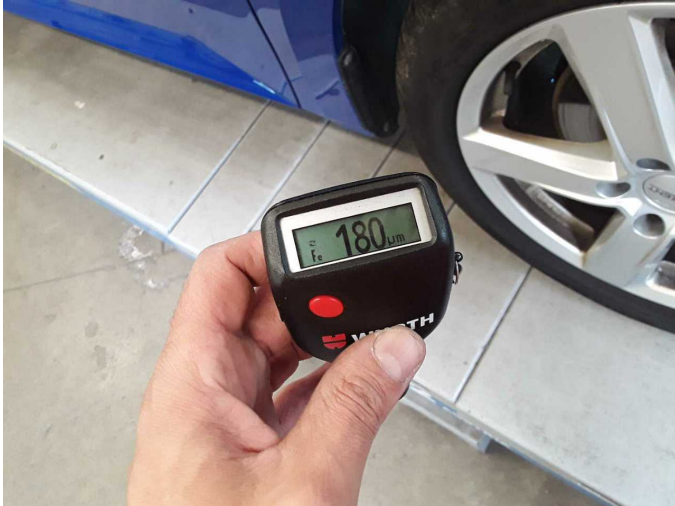
Repainting 1: Boot lid / rear door, Mudguard - right side, Side panel - rear right side, Door - rear right side, Door - front right side

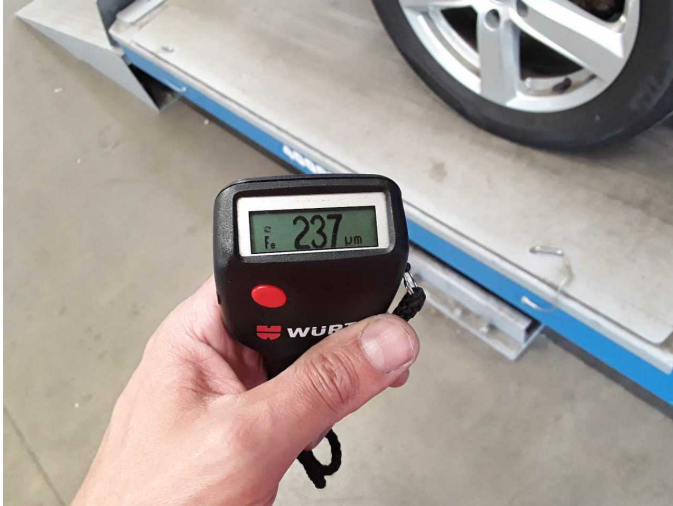
Repainting 1: Boot lid / rear door, Mudguard - right side, Side panel - rear right side, Door - rear right side, Door - front right side

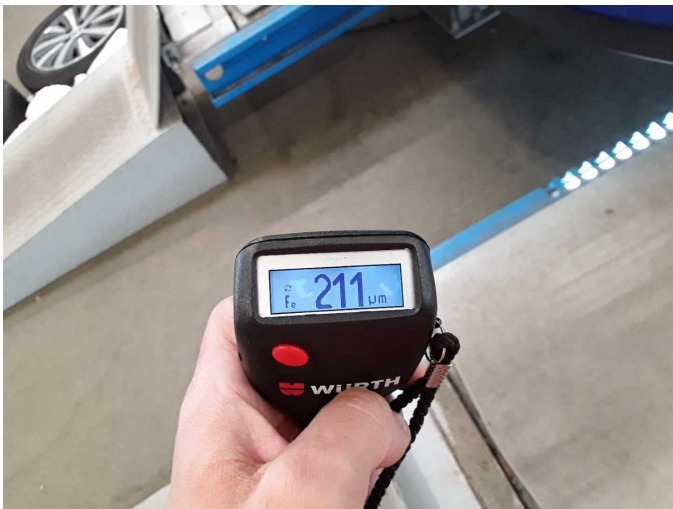
Repainting 1: Boot lid / rear door, Mudguard - right side, Side panel - rear right side, Door - rear right side, Door - front right side
