Expertise

Protocol number: 45296696
Order No. / Reference: 26191102-1
Inspection date: 30 Mar 2026

Model: 308 SW BlueHDi 130 EAT8 Allure Pack

VIN: VR3FCYHZTNY580628

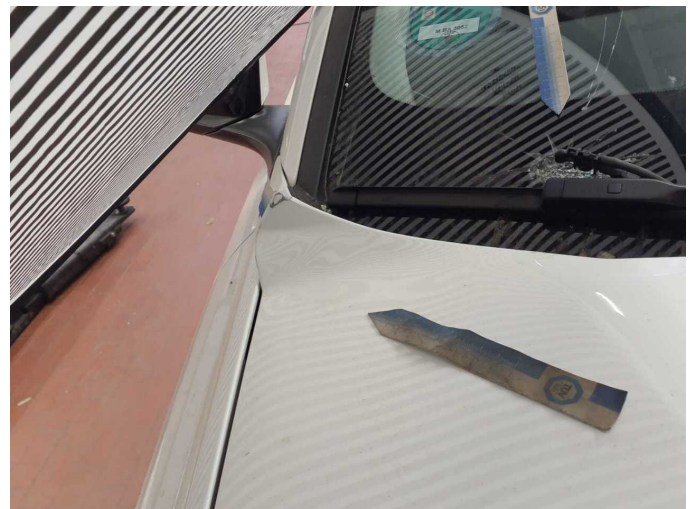
Accident 1: Front, Side - left, Side right

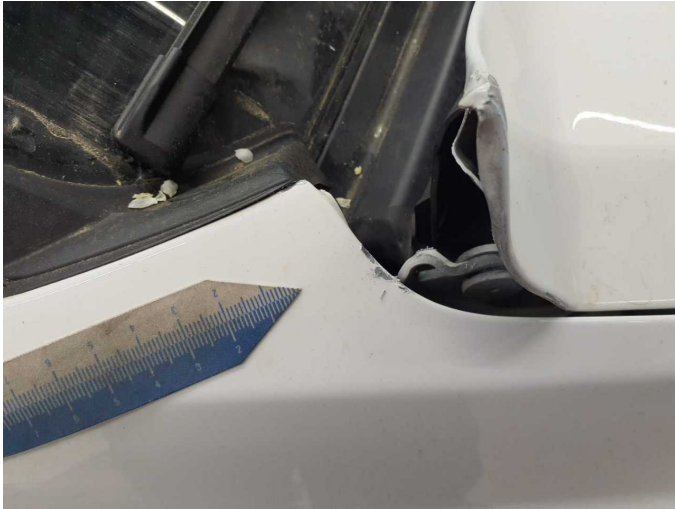
Accident 1: Front, Side - left, Side right

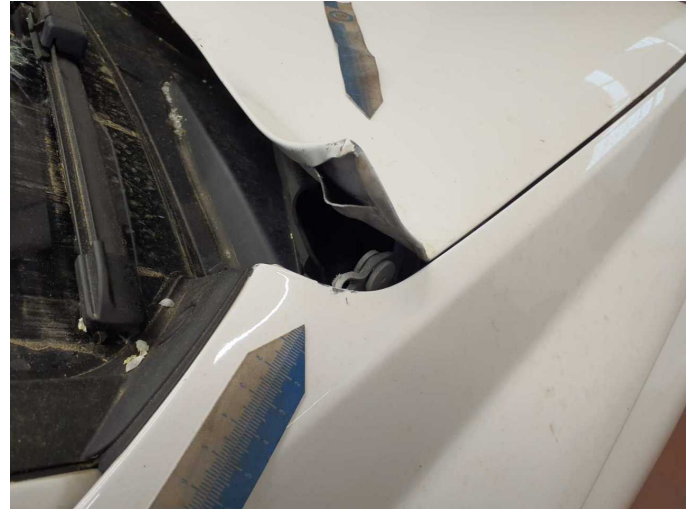
Accident 1: Front, Side - left, Side right

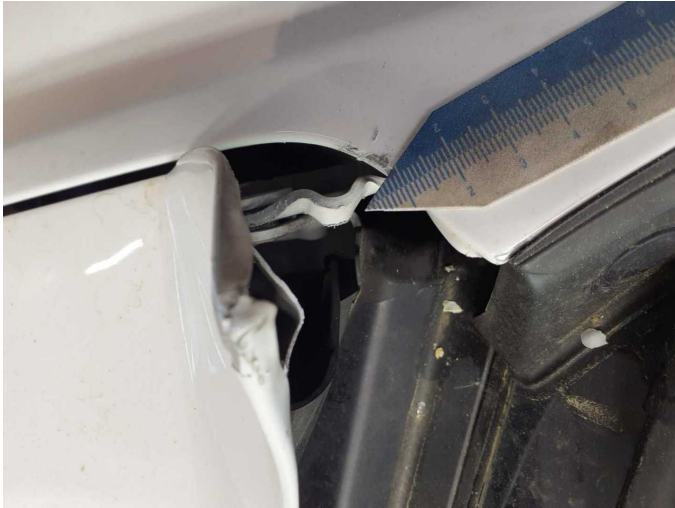
Accident 1: Front, Side - left, Side right

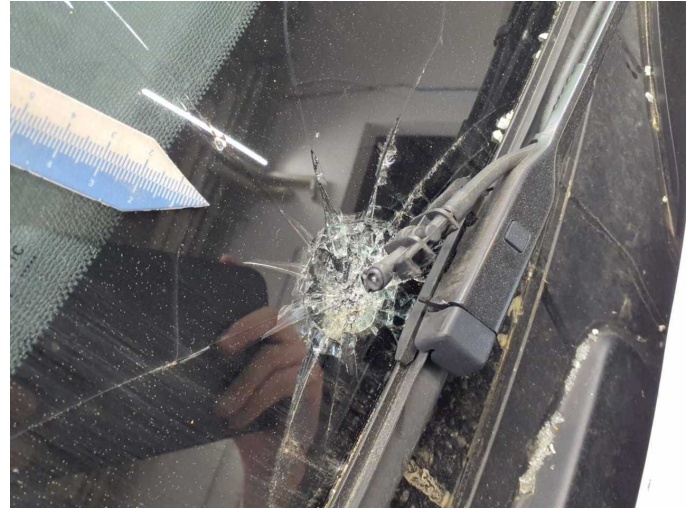
Accident 1: Front, Side - left, Side right

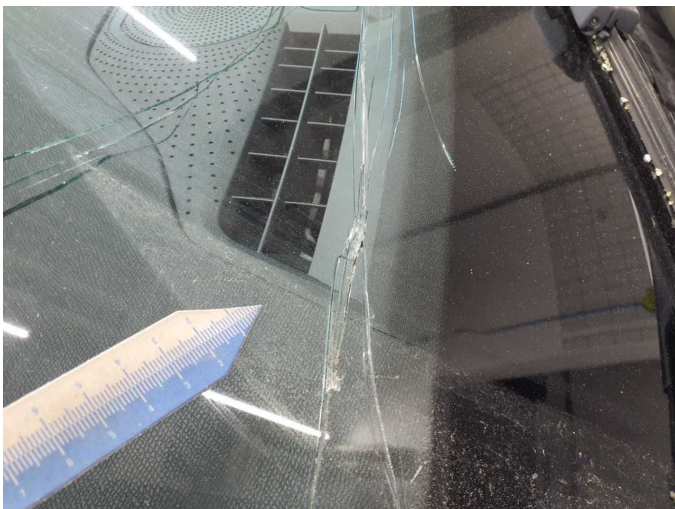
Accident 1: Front, Side - left, Side right

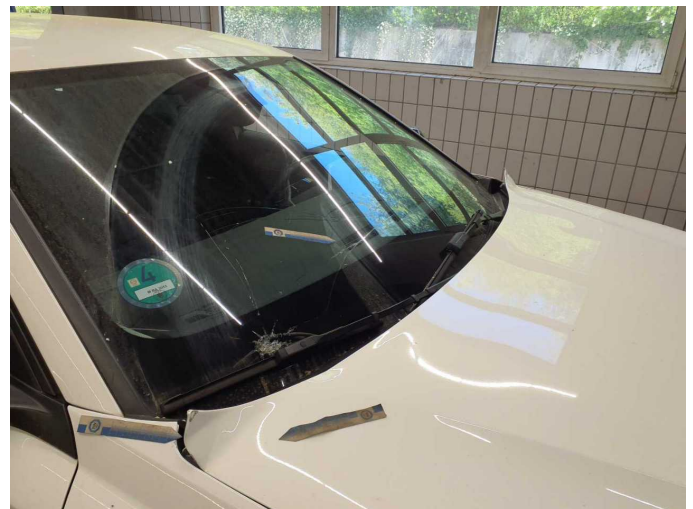
Accident 1: Front, Side - left, Side right

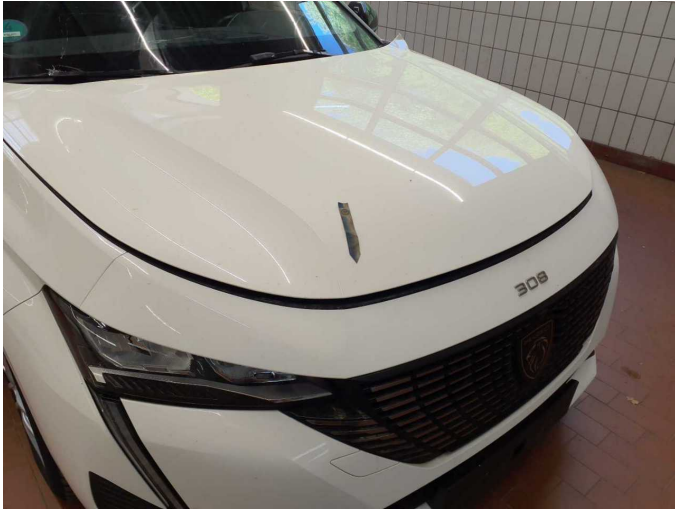
Accident 1: Front, Side - left, Side right

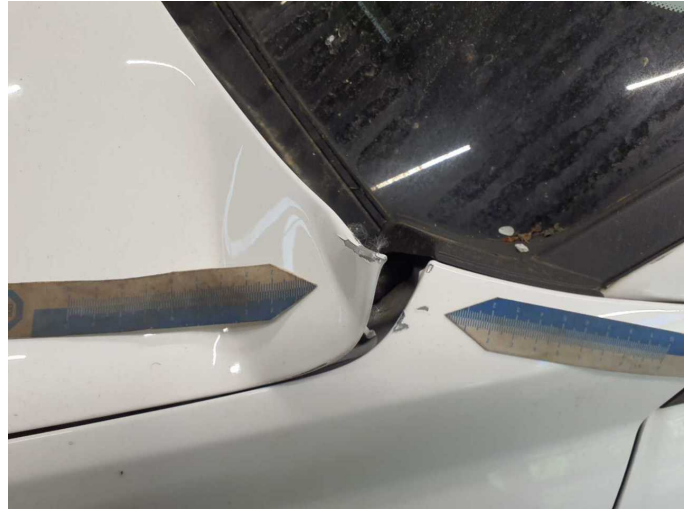
Accident 1: Front, Side - left, Side right

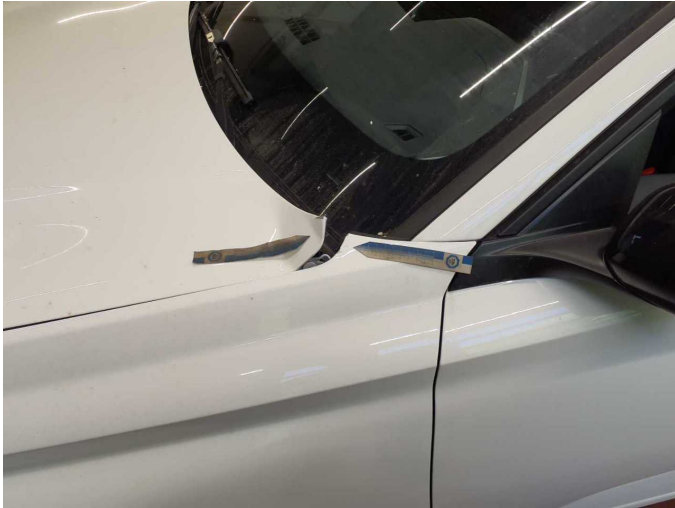
Accident 1: Front, Side - left, Side right

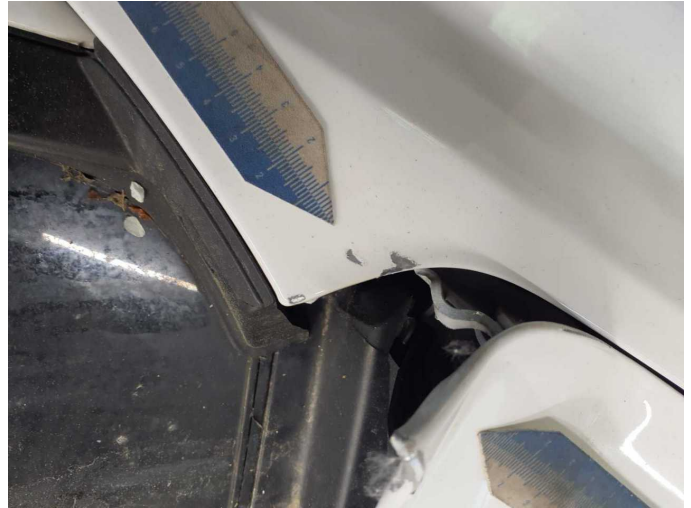
Accident 1: Front, Side - left, Side right

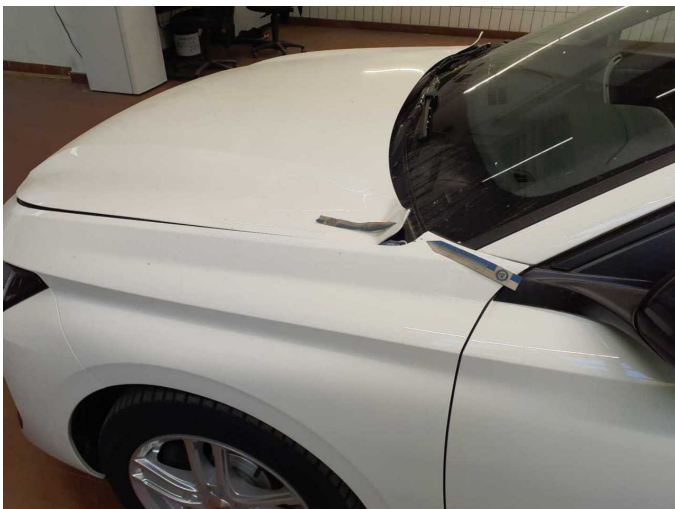
Accident 1: Front, Side - left, Side right

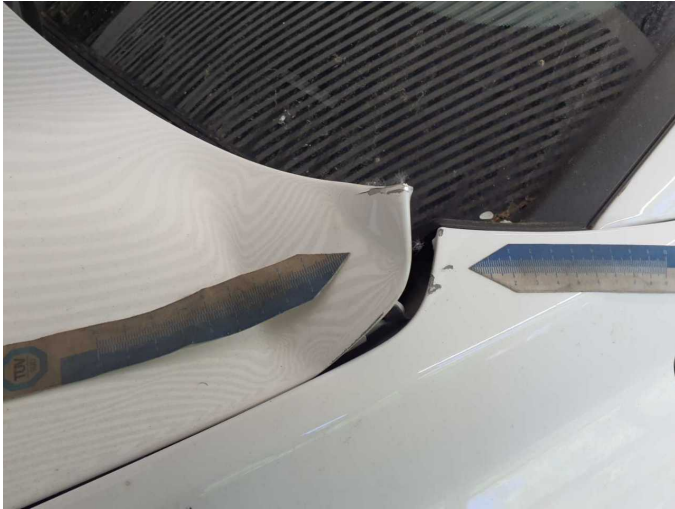
Accident 1: Front, Side - left, Side right

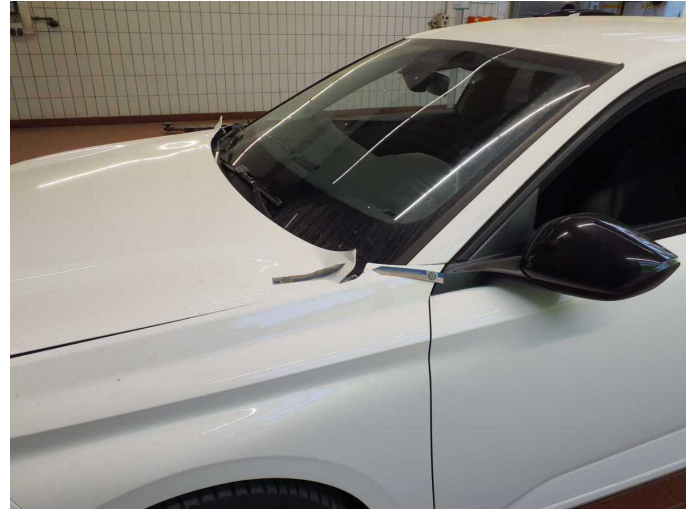
Accident 1: Front, Side - left, Side right

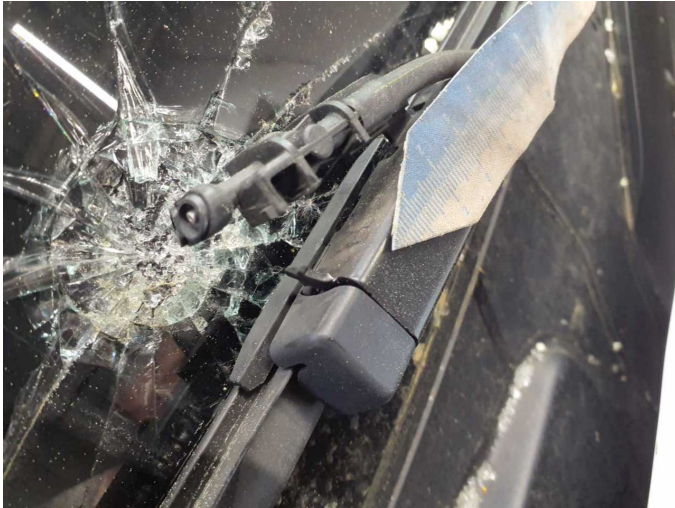
Accident 1: Front, Side - left, Side right

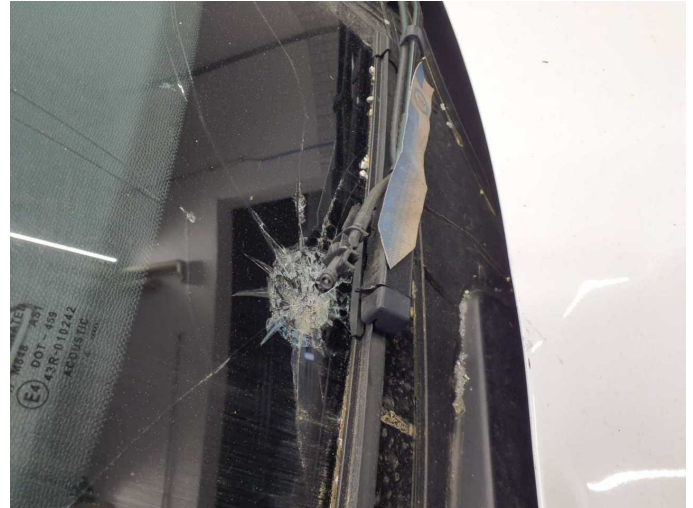
Accident 1: Front, Side - left, Side right

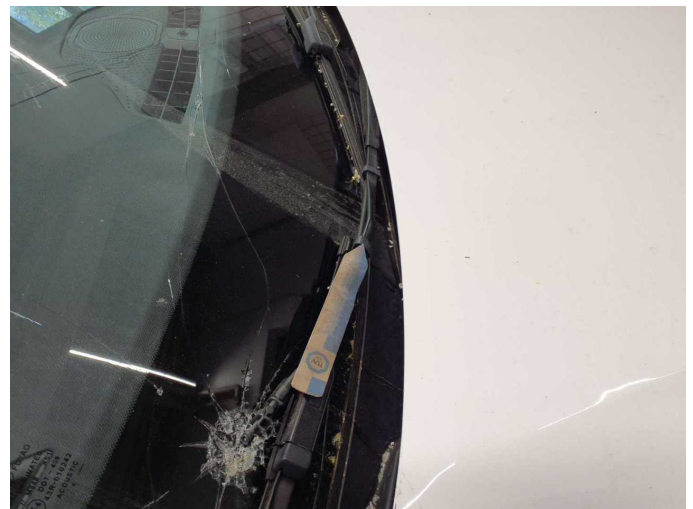
Accident 1: Front, Side - left, Side right

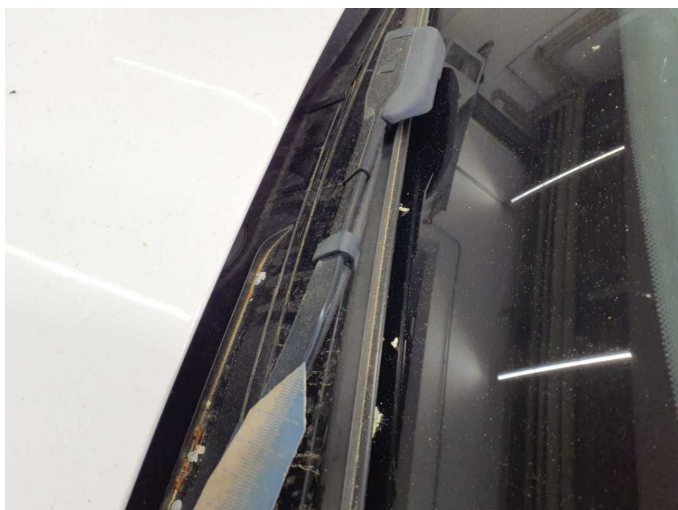
Accident 1: Front, Side - left, Side right

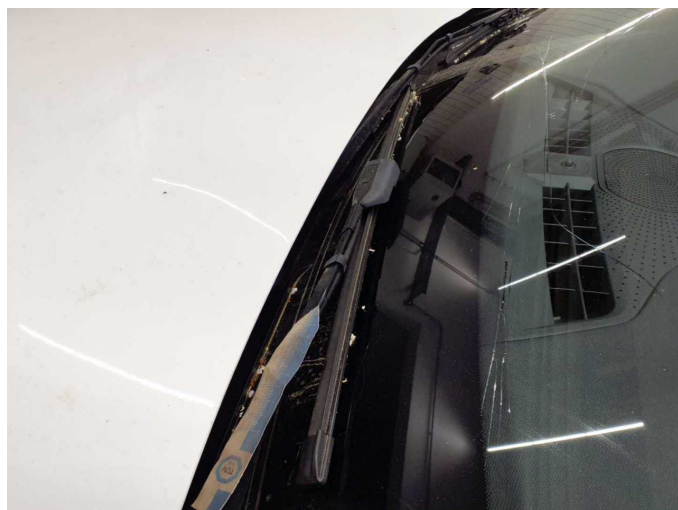
Accident 1: Front, Side - left, Side right
