Expertise

Protocol number: 45444058
Order No. / Reference: 26406183
Inspection date: 12 May 2026

Model: Superb Combi 2.0 TDI 4x4 DSG L&K

VIN: TMBLR7NP7P7030728

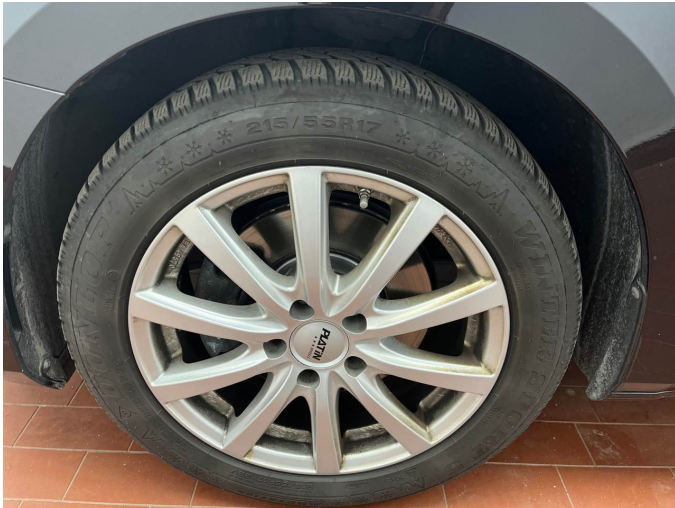
Figure 13: Mounted tyres

Mounted tyres				
#	Tyre size	Type of tyre	Manufacturer	Tread depth
1)	215/55 R17 98V	Winter tyres on Light alloy	Dunlop	5mm / 5mm
2)	215/55 R17 98V	Winter tyres on Light alloy	Dunlop	7mm / 7mm
Additional tyres				
#	Tyre size	Type of tyre	Manufacturer	Tread depth
1)	235/45 R18 94W	Summer tyres on Light alloy	Goodyear	5mm / 5mm
2)	235/45 R18 94W	Summer tyres on Light alloy	Goodyear	6mm / 6mm
Replacement				
Typ	Tyre size	Type of tyre	Manufacturer	Tread depth
	Tirefit	Expiration date 10/2026
