Expertise

Protocol number: 46896083  
Order No. / Reference: 26591774  
Inspection date: 30 Jul 2026

| Manufacturer: Opel | Model: Insignia Sports Tourer 2.0 Diesel Aut. Business |
| VIN: W0VZT8GP3N1007371 | |

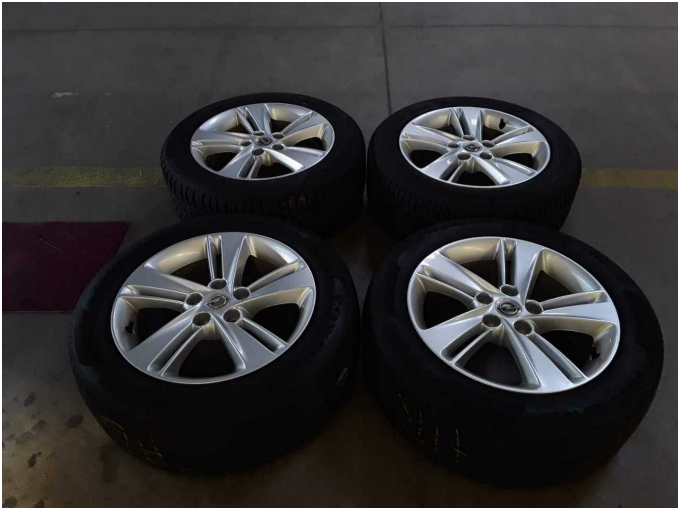
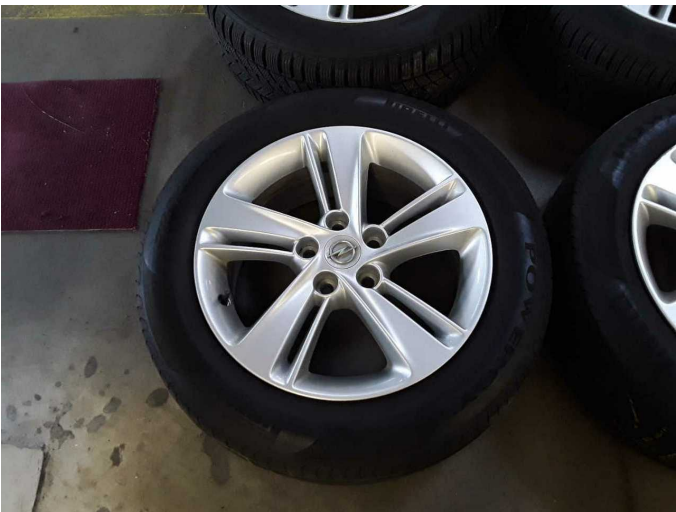
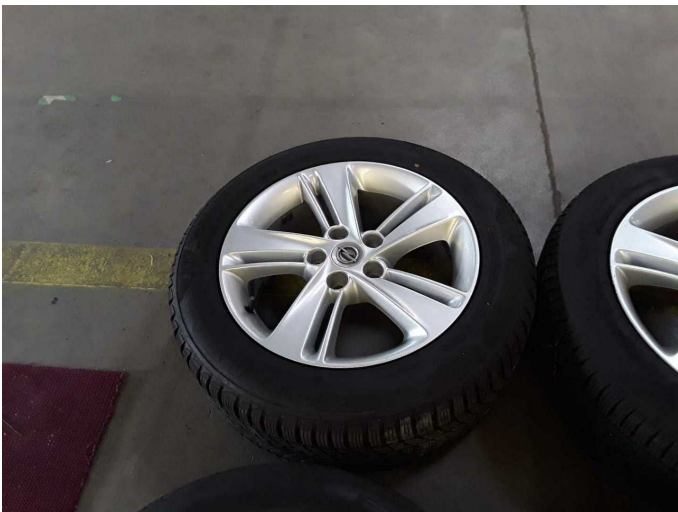
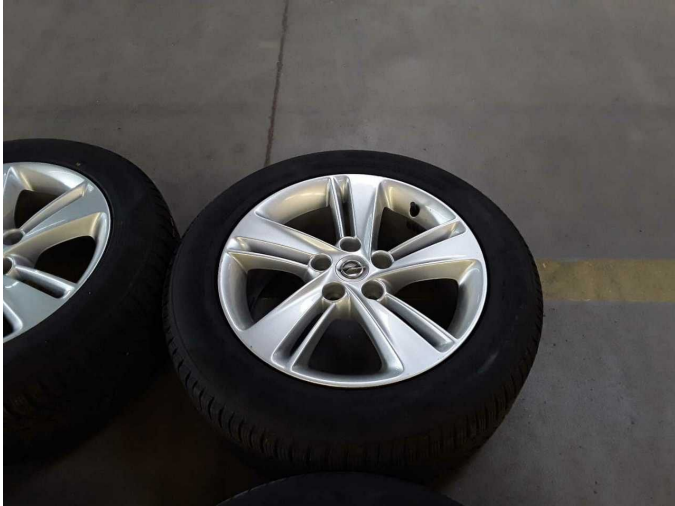
| No. | Component group | Description |
|---|---|---|
| 7 | 2nd wheel set | 2 tyres (<2mm) - Does not meet the leasing specifications - Replace |

Figure 22: Additional tyres

Figure 23: Additional tyres

Figure 24: Additional tyres

Figure 25: Additional tyres
