Expertise

Protocol number: 46325258
Order No. / Reference: 26574197
Inspection date: 25 Jun 2026

Manufacturer: Mercedes-Benz

Model: eVito Tourer 129 Lang PRO

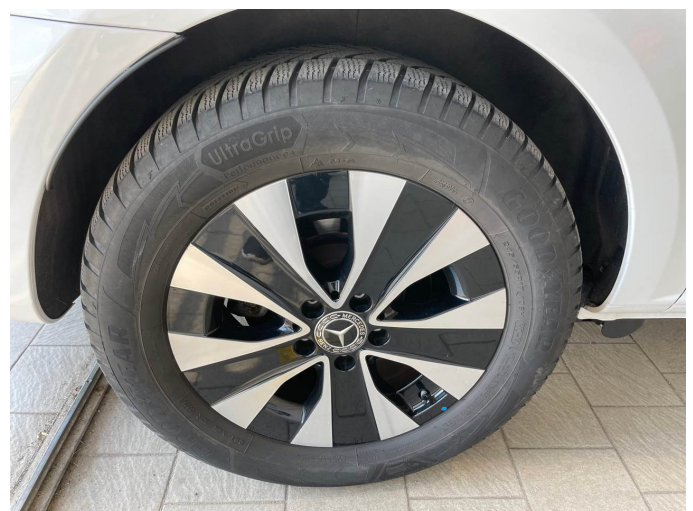
Figure 12: Mounted tyres

#	Tyre size	Type of tyre	Manufacturer	Tread depth
1)	245/55 R17 106H	Winter tyres on Light alloy	Goodyear	4mm / 4mm
2)	245/55 R17 106H	Winter tyres on Light alloy	Goodyear	7mm / 7mm

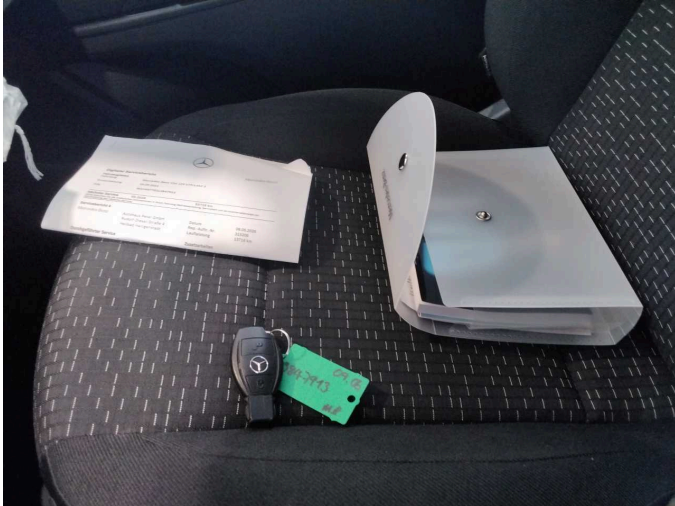
Figure 13: Documents

Documents submitted	At the time of the inspection, the vehicle registration certificate Part 2 (title) was available, but the vehicle registration certificate Part 1 (document) was not. (Copy)
VIN comparison	The vehicle identification number (VIN) was read from the vehicle and its conformity with the submitted documents was confirmed by the undersigned during the inspection.
Inspection	The inspection conditions were sufficient for the assessment of the vehicle. No lifting equipment or pit was available for inspecting the vehicle. Therefore, inspection of the vehicle's underside was only possible to a limited extent.
Test drive	No test drive/shunting maneuver was carried out during the inspection of the vehicle.
Engine function test	An engine test run was performed.
readiness to drive	The vehicle was roadworthy at the time of inspection.
