Expertise

Protocol number: 45546987
Order No. / Reference: 26368388
Inspection date: 19 May 2026

Manufacturer: Opel

Model: Astra 1.5 D Automatik Business Elegance

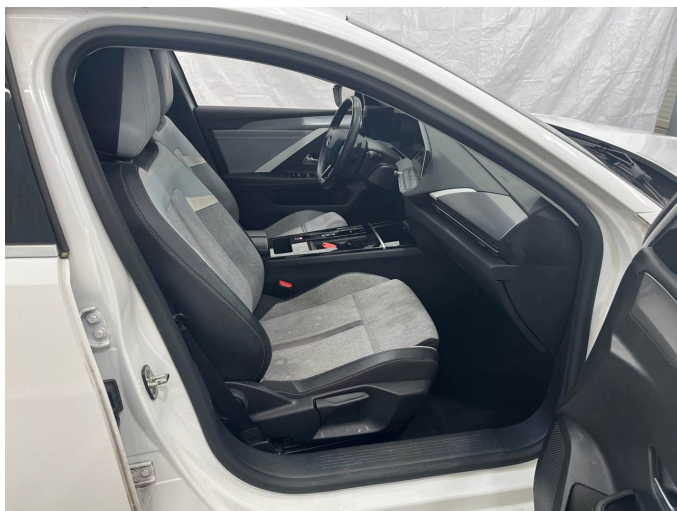
Figure 5: Interior - front

No.	Component group	Description
1	Misc.	Main inspection - No evidence - No deduction
2	Body	Body - Glued / labelled - De-glue / neutralise
3	Interior	Interior (Sitze vorne stark verschmutzt, Mehraufwand möglich) - Soiled - Clean
4	Bonnet	Insulation lining - Damage caused by marten / rodent - Replace
5	2nd wheel set	1 alloy rim - Scratched - Loss in value
6	2nd wheel set	1 alloy rim - Scratched - Loss in value

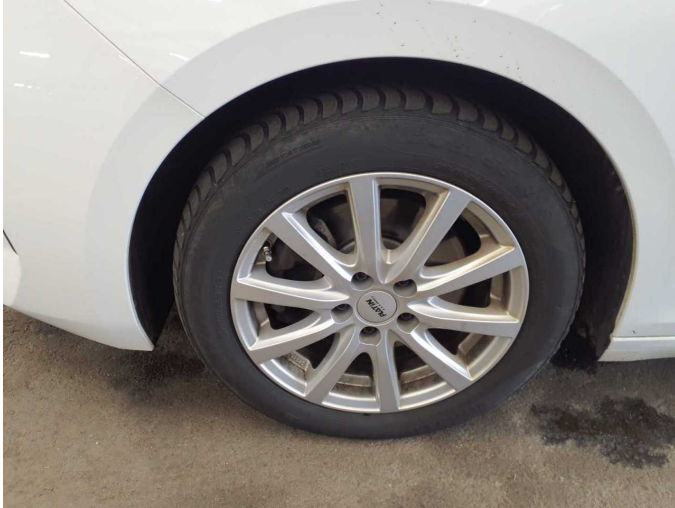
Figure 13: Mounted tyres

#	Tyre size	Type of tyre	Manufacturer	Tread depth
1)	205/55 R16 91H	Winter tyres on Light alloy	Pirelli	4mm / 4mm
2)	205/55 R16 91H	Winter tyres on Light alloy	Pirelli	4mm / 4mm

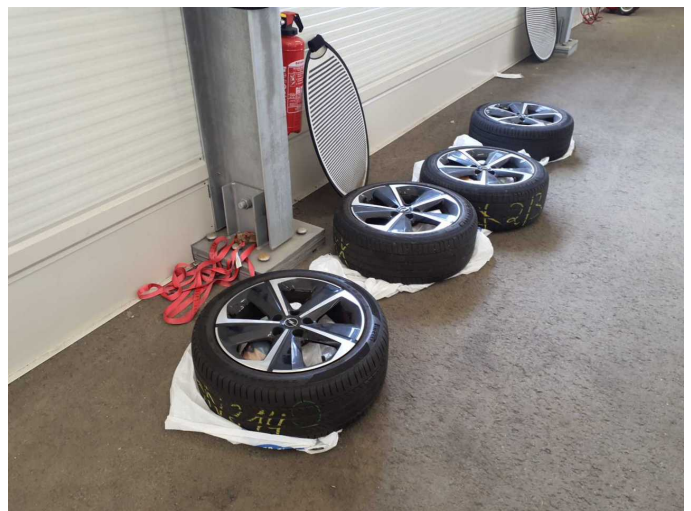
Figure 18: Additional tyres

#	Tyre size	Type of tyre	Manufacturer	Tread depth
1)	225/45 R17 94Y	Summer tyres on Light alloy	Pirelli	4mm / 4mm
2)	225/45 R17 94Y	Summer tyres on Light alloy	Pirelli	4mm / 4mm
