Expertise

Protocol number: 46385288  
Order No. / Reference: 26512547  
Inspection date: 2 Jul 2026

Manufacturer: Skoda  
VIN: TMBJC7NY9NF019119

Model: Enyaq iV 80

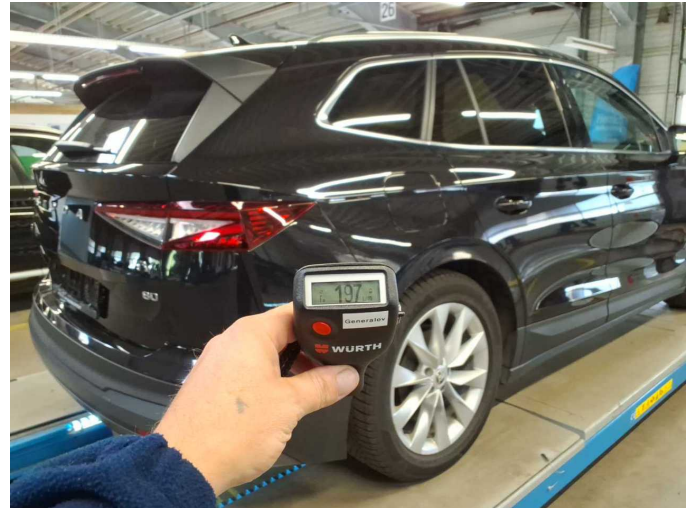
**Repainting 6:** Side panel - rear right side

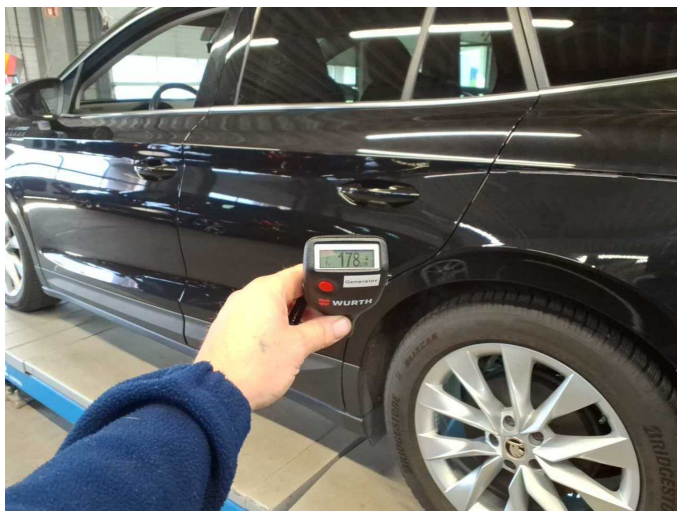
**Repainting 7:** Door - rear left side
