Expertise

Protocol number: 46166343
Order No. / Reference: 26501253
Inspection date: 25 Jun 2026

Manufacturer: Volvo

Model: XC60 T6 AWD Recharge Plus Bright

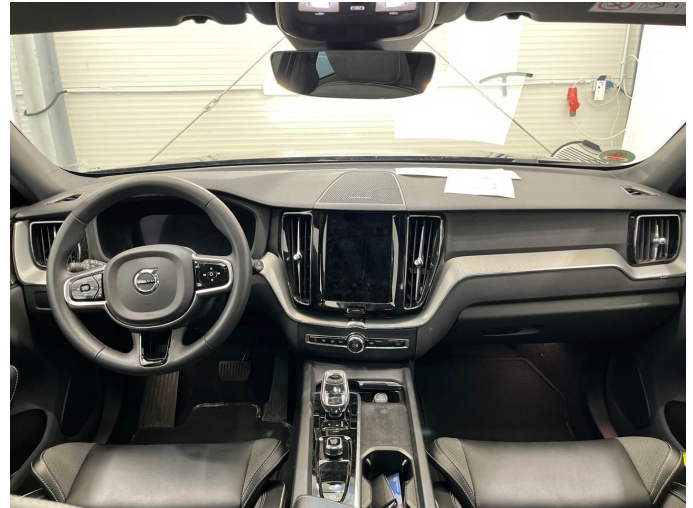
Figure 8: Instrument panel

No.	Component group	Description
1	Instrument panel	Indicator light (Scheinwerfersystem) - Specify findings - Perform diagnosis
2	Sill - right side	Sill - dent(s) - Smooth repair work
3	Side panel - rear right side	Sill - Scratch(es) - Smart repair
4	Instrument panel	Indicator light (Fahrerassistenzsystem) - Specify findings - Perform diagnosis
5	Wheel / tyres	Alloy rim - rear right side - Scratch(es) - Loss in value
6	Misc.	Inspection / maintenance - Due - Perform
7	Vehicle glazing	Windscreen with lane departure assistant - Broken / torn - Replace
